Esopus Creek News

Ashokan Watershed Stream Management Program Newsletter

Fall Floods 2010

Woodland Valley Road Protected from Erosion

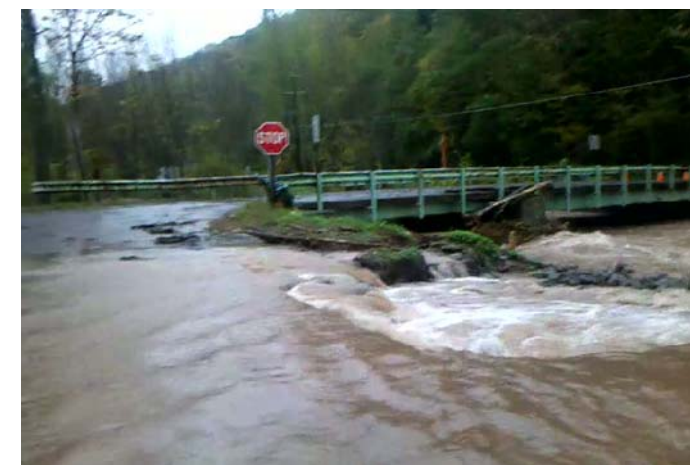
Brown Road in Olivera, damaged by flood water by McKinley Hollow Bridge

towns. Engineering designs were provided by the program to the Town of Shandaken to restore damaged stream reaches such as Woodland Creek across from the Roxmoor Inn, and the relocation of the Esopus Creek to its pre-flood stream channel at Brown Road in Olivera. The program also designed and will help to replace a washed out culvert in Trevor Hollow, which staff had identified as a problem culvert before the flood. Luckily, a streambank protection project near Fawn Hill Rd. was completed before the flood, as the eroding bank was an imminent threat to Woodland Valley Rd (see article pg. 2). After the flood, a second site, by the Roxmoor

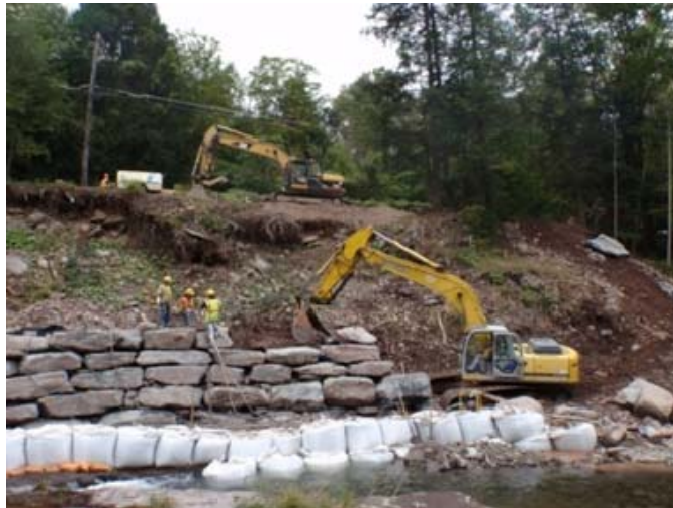
Rock is placed at the toe of the eroding slope on Woodland Creek. Large sand bags prevent construction runoff into the stream

tion, and Shandaken Highway Superintendent Eric Hoffmeister worked together over the last year to design, fund and implement a solution for the Woodland Valley Creek site. The engineered design includes a stacked rock wall, a bioengineered hillside, drainage, and riparian tree plantings to mitigate this community hazard. Funding for this project is coming from a FEMA Hazard Mitigation Grant received by the town and a grant from the Ashokan Watershed Stream Management Program Implementation Fund.

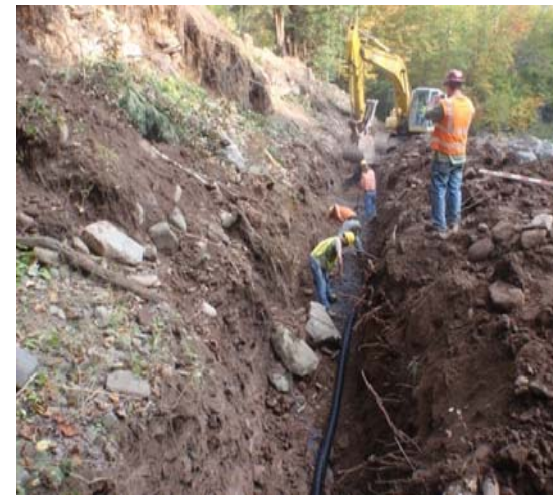
Drainage pipe placed before construction of the wall.

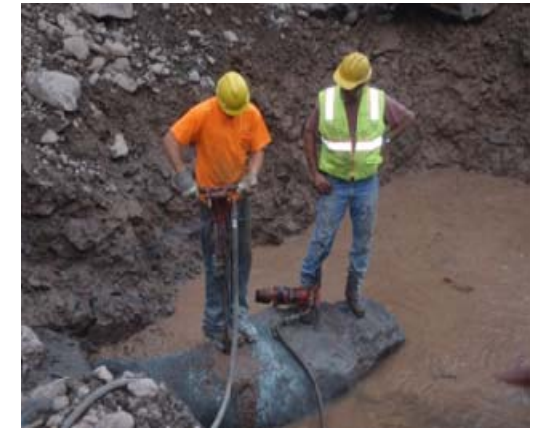
Rocks pinned to bedrock with steel rebar

A significant design aspect to this project is that the rocks are fit tightly, pinned together and pinned to bedrock with rebar, making the wall act as a single unit. "The excavator is almost like an artist, finding the right rock and fitting it in just the right place," said Jake Wedermeyer, staff for UCSWCD. Where bedrock is not available for a foundation, a footing trench can be used.

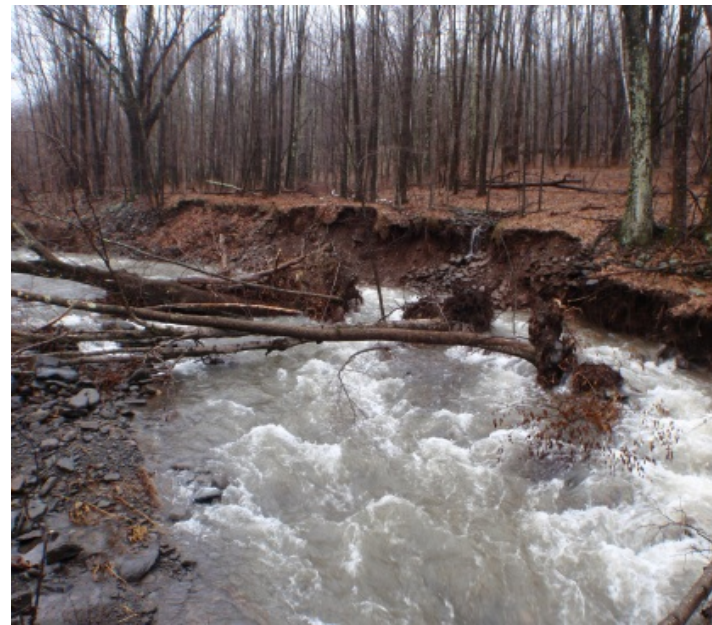
Bank erosion from trees that were not cut before falling into the stream

Ultimately, large woody debris should only be removed from streams in circumstances when buildings or infrastructure is threatened. One of the easiest management practices that a landowner can do to protect their stream bank is to cut up and remove trees likely to fall into the channel within the next year, but leave the rootwad intact in the stream bank. Large woody debris that is perpendicular to the stream channel can be moved to an angle between a 20° and 40° to the bank (with the open angle downstream). This makes it less likely to have an erosive effect on the stream bank.

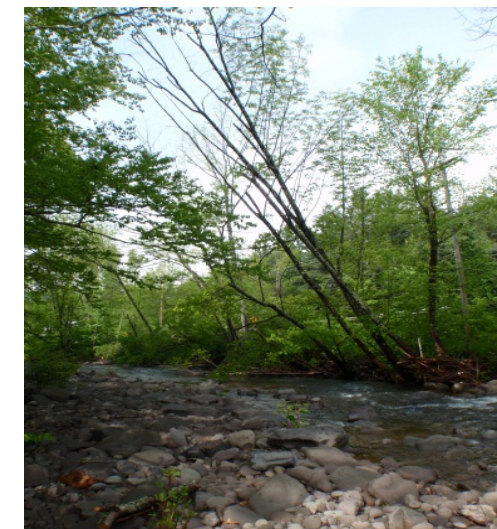
Cantilevered trees that can be cut above the rootwad to help maintain bank stability

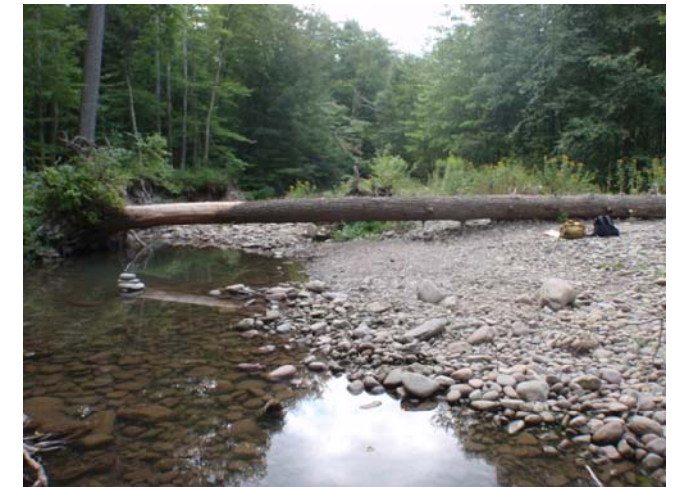
Channel-spanning large woody debris that is unlikely to be moved during most large floods

The stability of large woody debris is a function of two main factors: the size of the tree, and the size of the stream. Research shows that a general rule for determining the stability of large woody debris is if the tree is longer than the channel width, it is much less likely to be moved by regular flood flows.

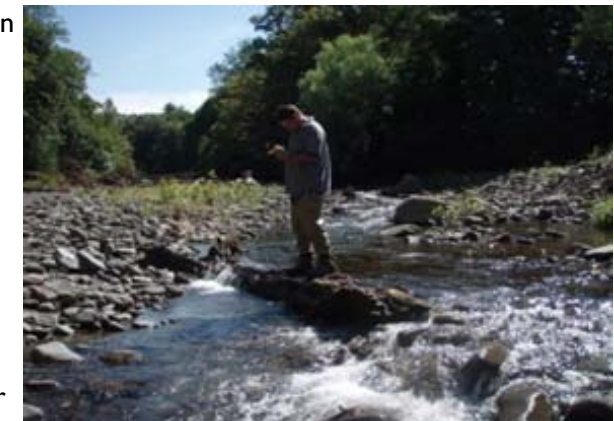
Embedded log holding sediment and acting as a grade control

- Stumps on the bank, unless severely undercut
- Large woody debris structures, such as embedded logs, which are retaining sediments and acting as a grade control
- Large woody debris that is naturally providing bank protection
- Large woody debris structures that are directly creating stream habitat.

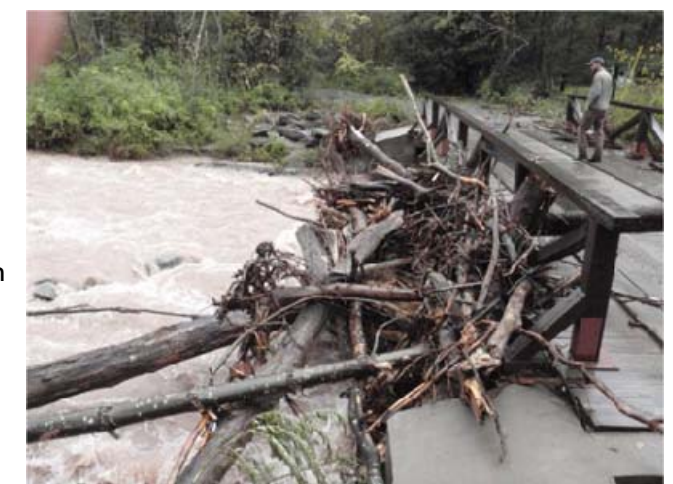
Woody Debris can cause damage to bridges if not removed or there is not enough space for the debris to pass under the bridge
