Interactions between Human & Natural Systems along Rural Road Networks: the case of the Lake Champlain basin

University of Vermont

Catskills Environmental Research and Monitoring Conference

October 25, 2018

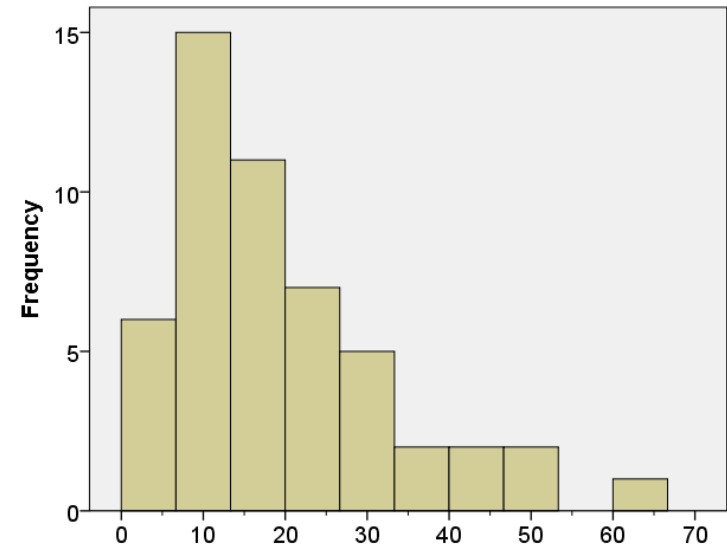
Erosional feature frequency (#/km)

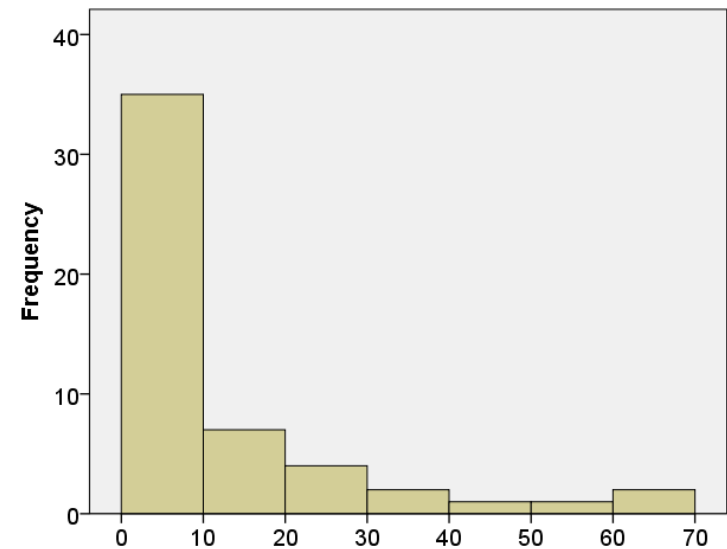
Volume of eroded sediment (m^3/km)

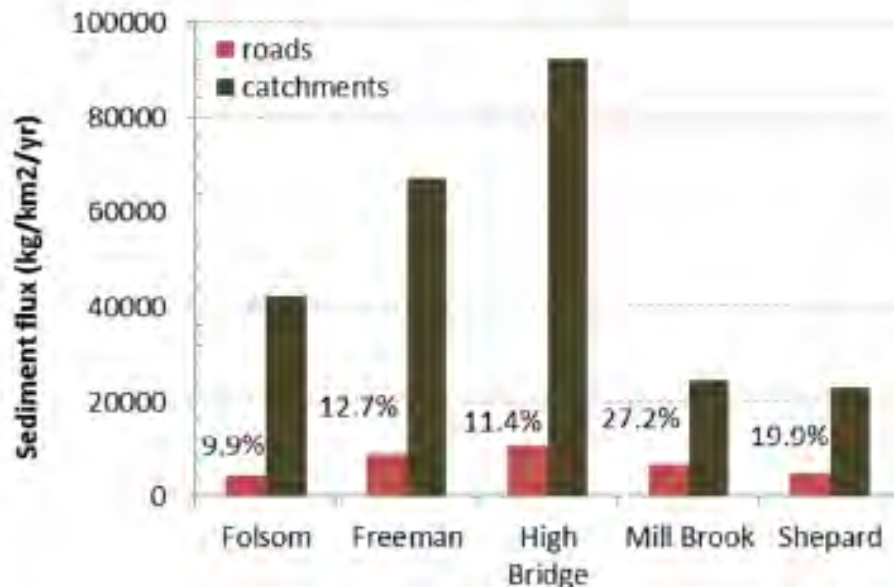
Suspended Sediment

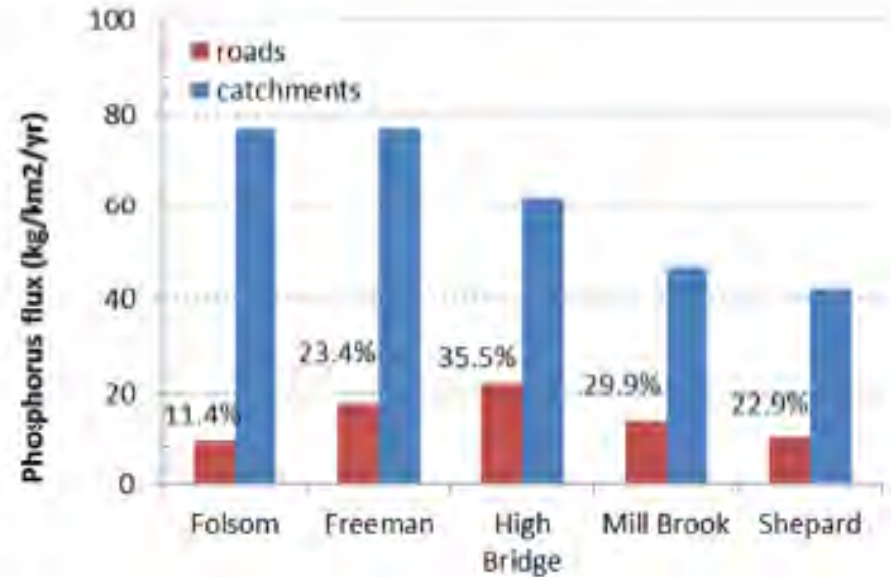
Total Phosphorus

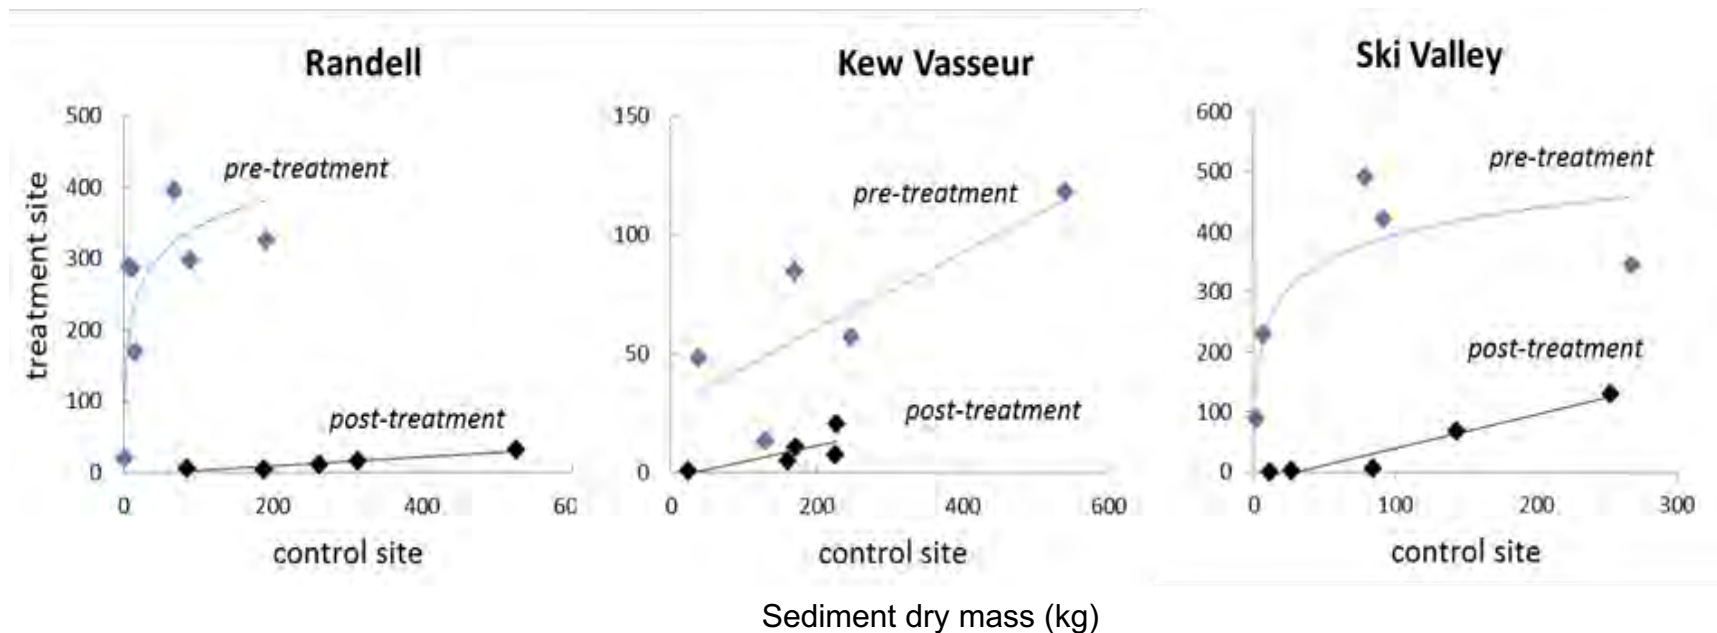
Treatment: Stone lined ditches

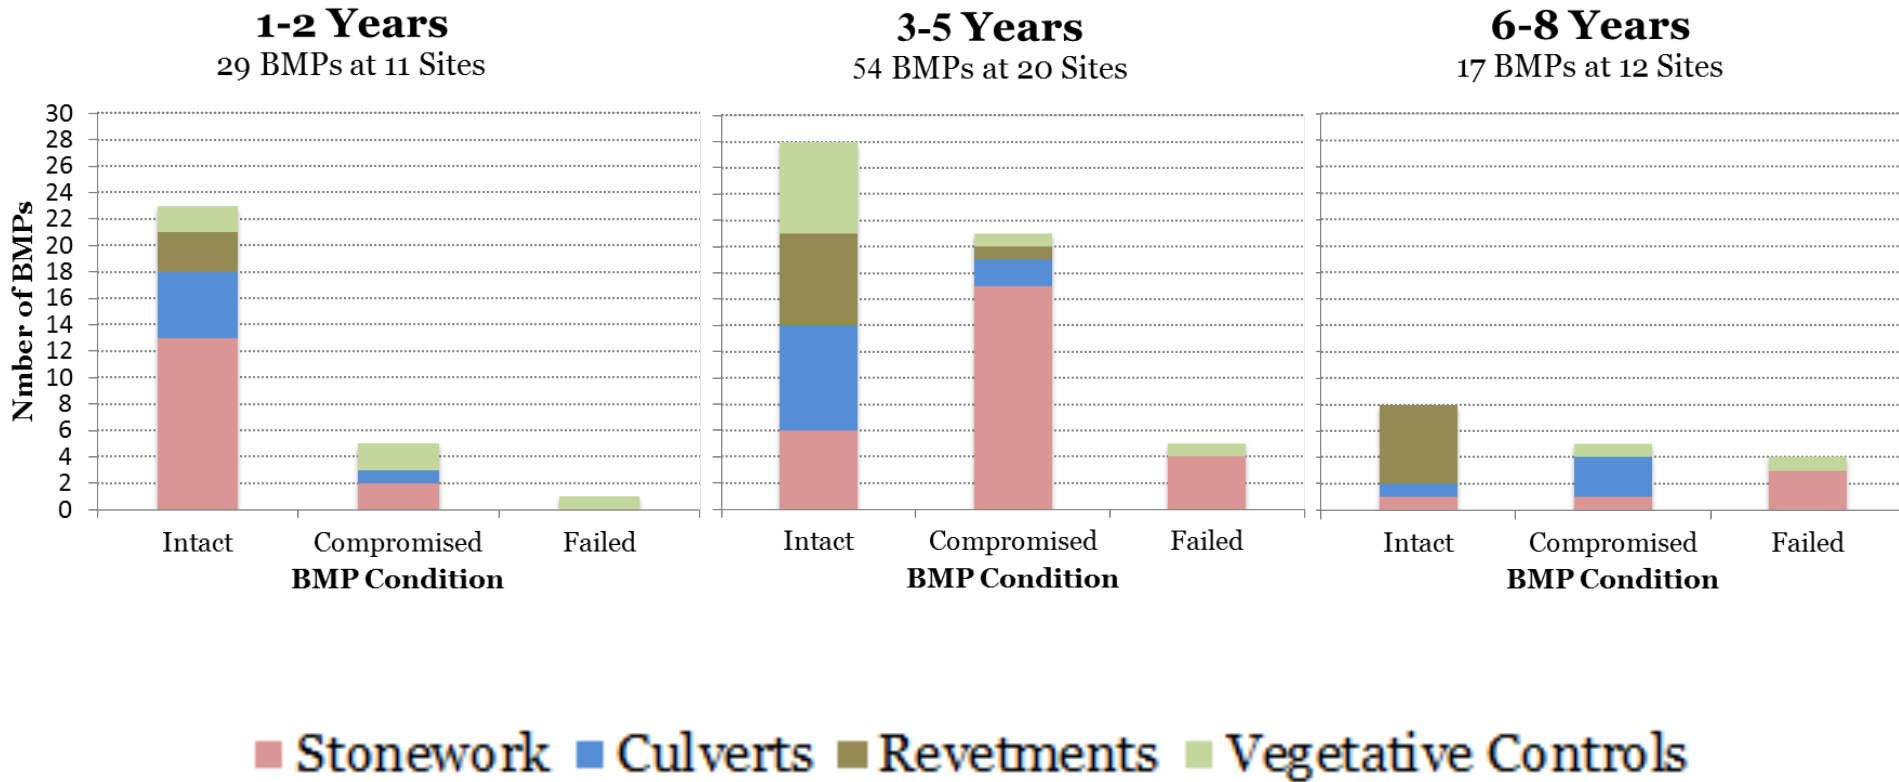
BMP persistence with time

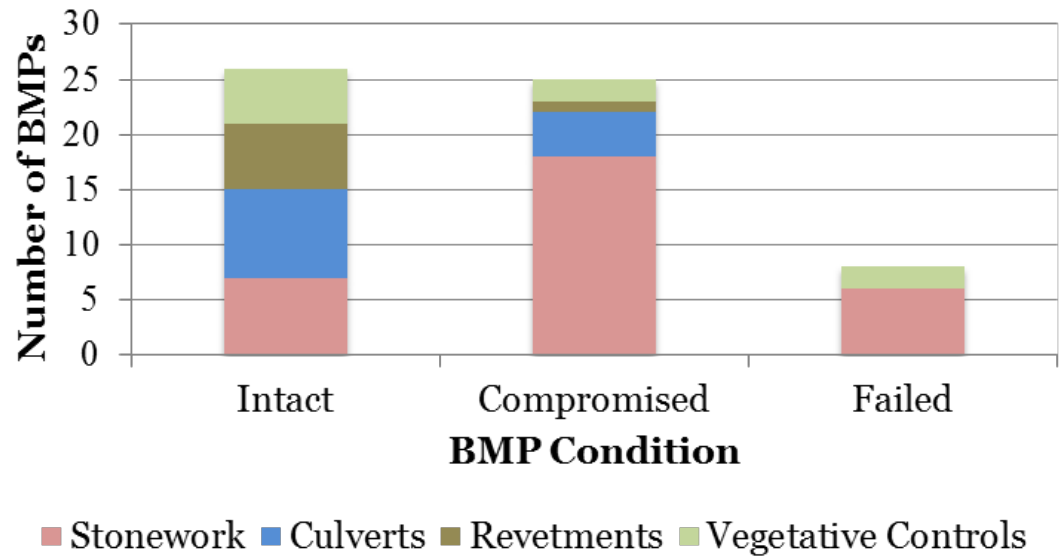
BMP effectiveness with flood exposure

Exposed to flood events

59 BMPs at 23 Sites

Average Age 4.8 years, SD 1.6

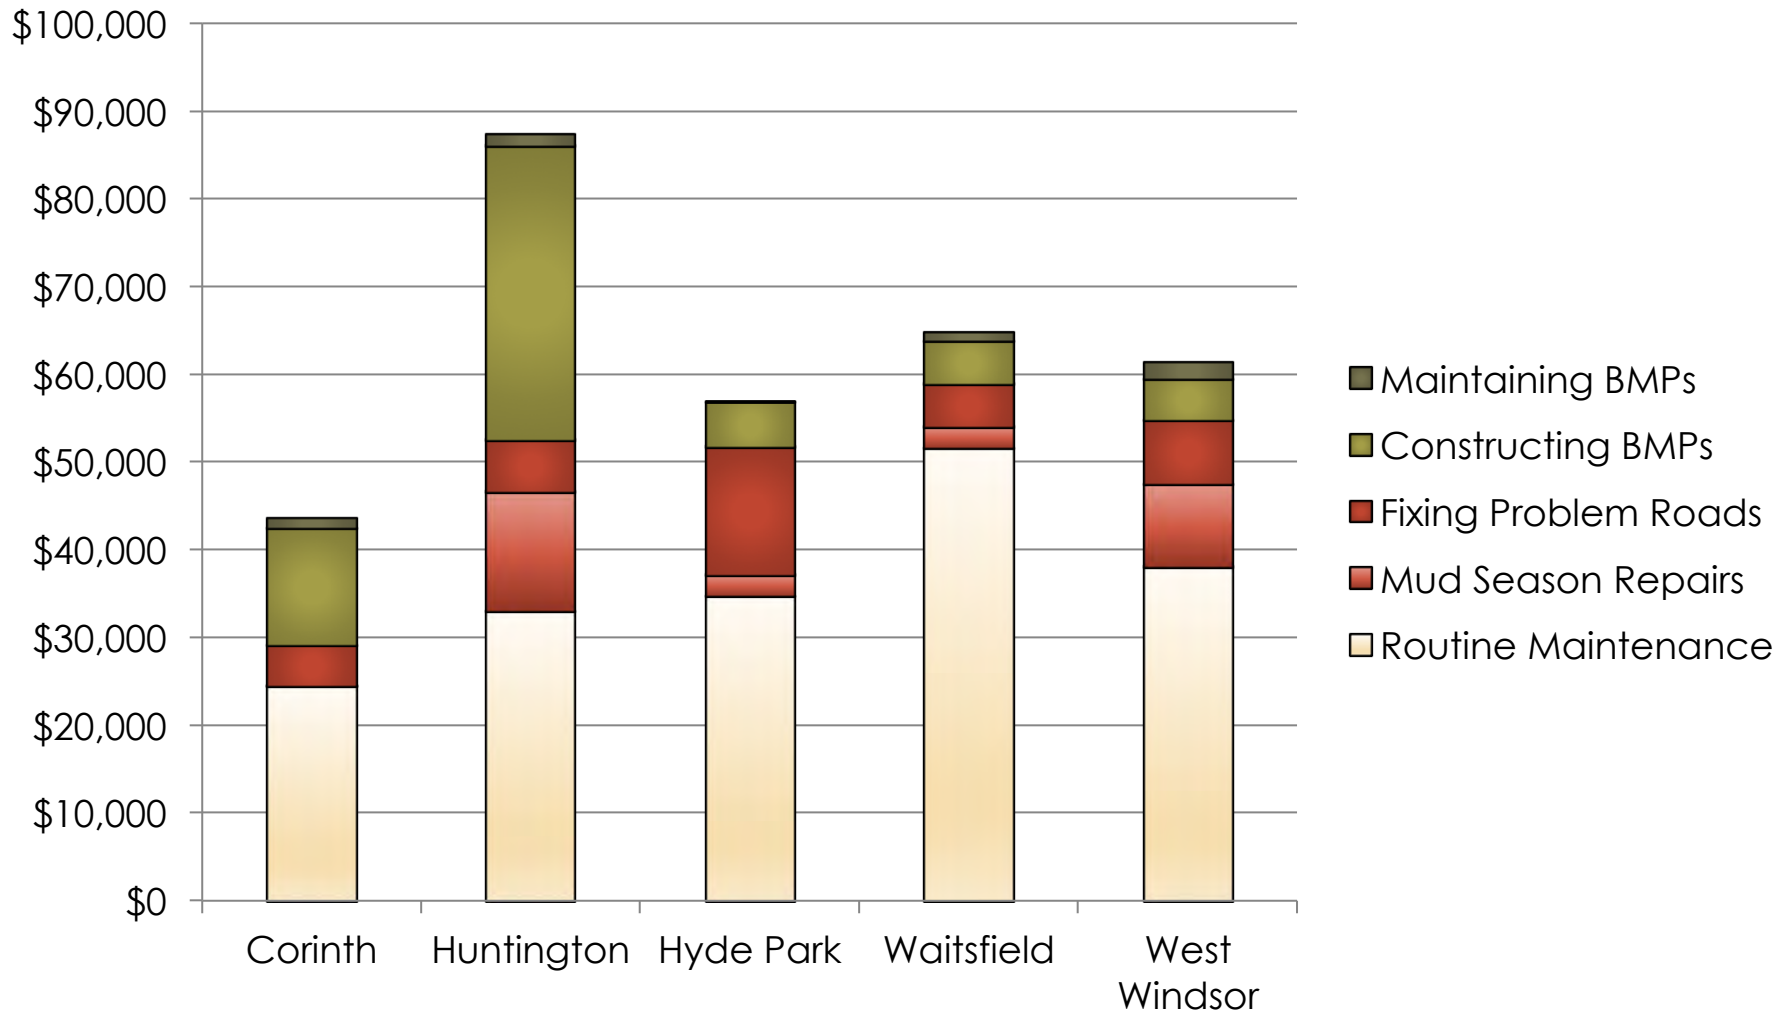
Distribution of road crew salary by non-winter unpaved road maintenance tasks

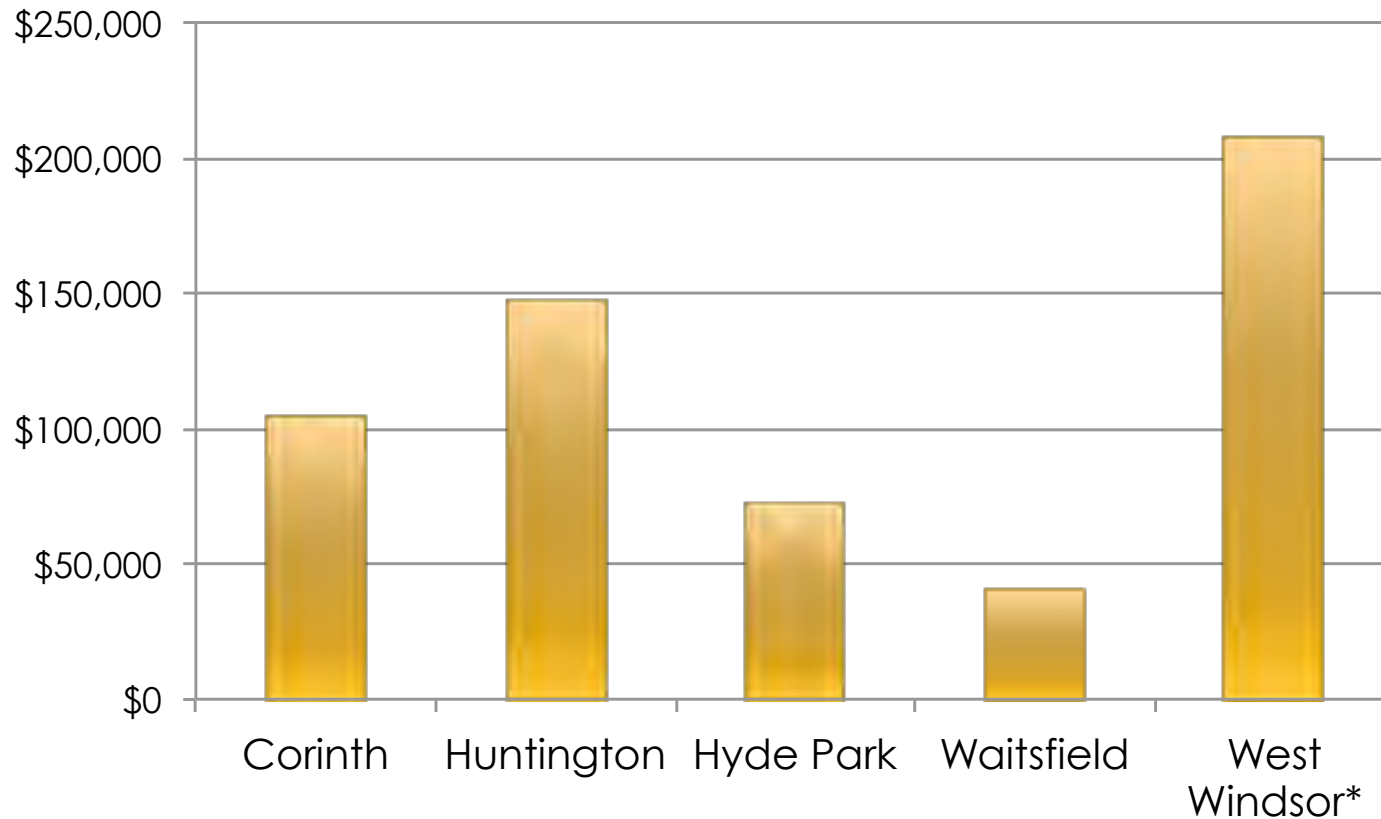
Materials costs

non-winter unpaved road maintenance

* West Windsor materials total includes \$55,686.81 of itemized equipment rental, materials and trucking as a needed after a 2013 flood event

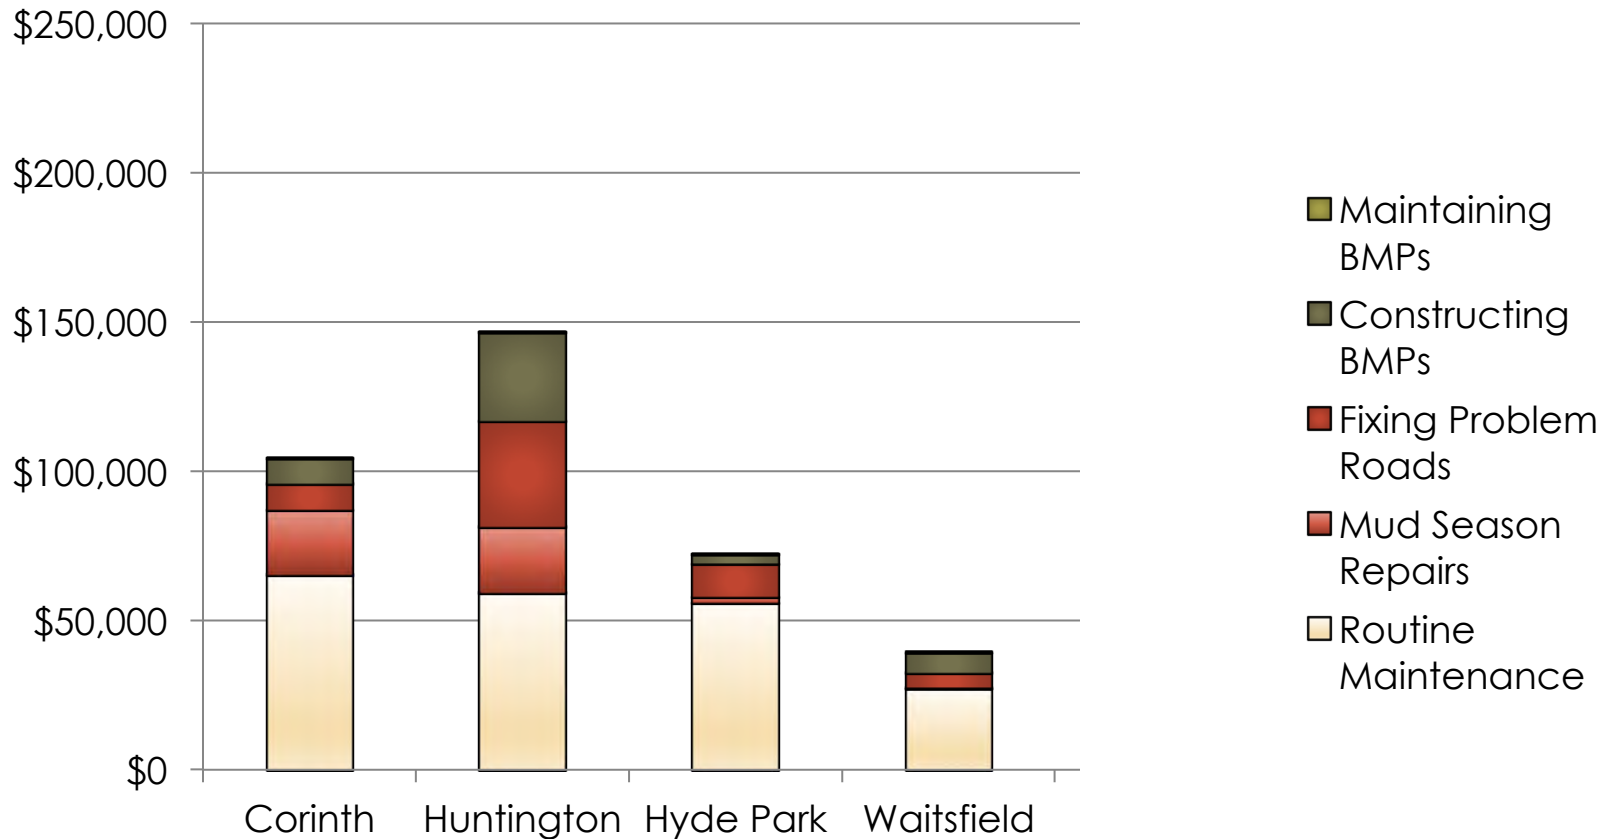
Distribution of materials costs by non-winter unpaved road maintenance tasks

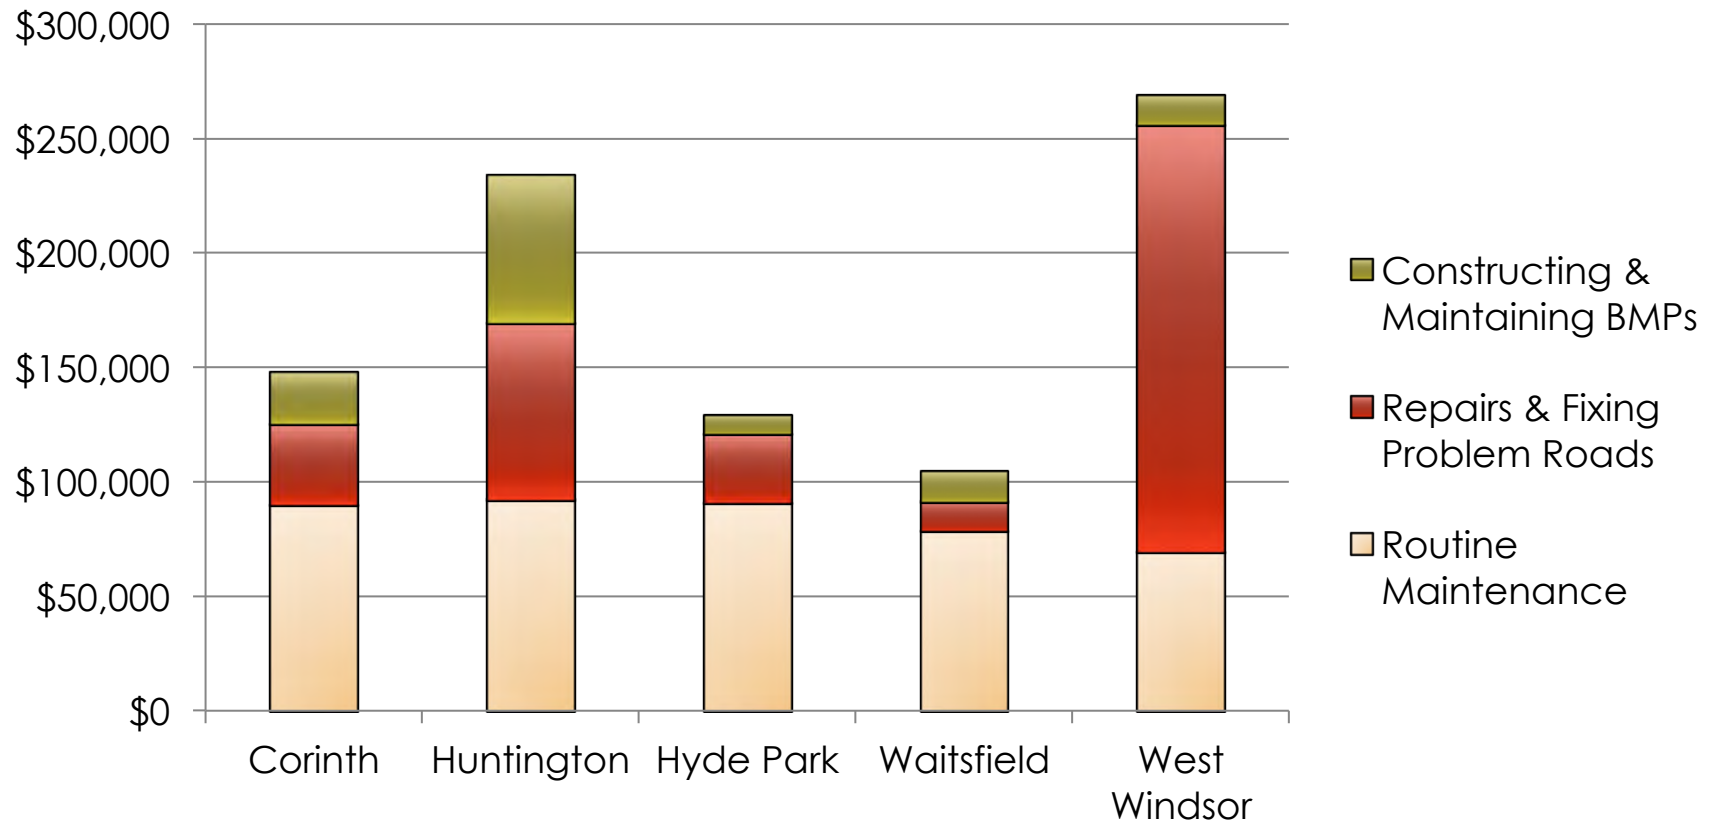
Total salary and materials costs unpaved non-winter road work

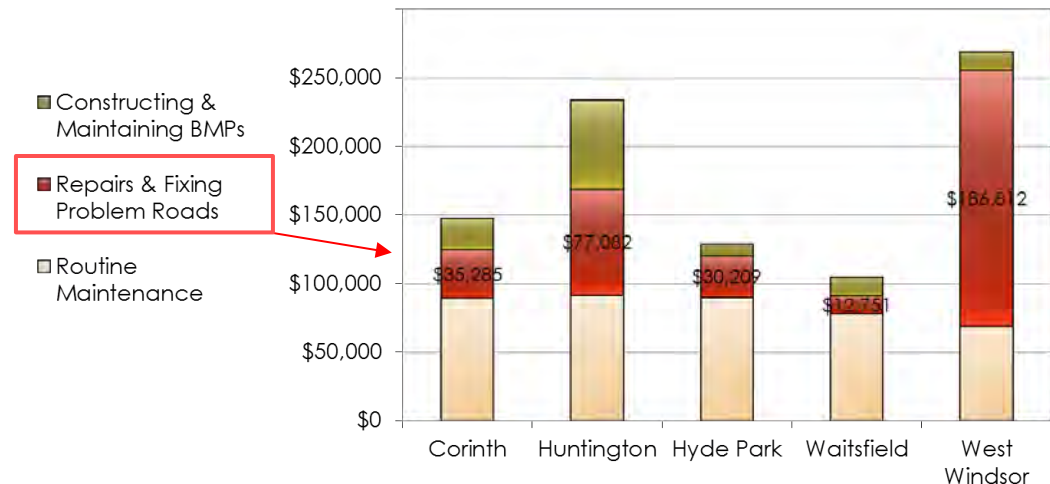
Allocations under current practices
