ASHOKAN WATERSHED STREAM MANAGEMENT PROGRAM

Using Bank Assessment for Non-point source Consequences of Sediment (BANCS) model to prioritize potential stream bank erosion on Birch Creek, Shandaken, New York.

Graham Markowitz¹
Sara Newton²

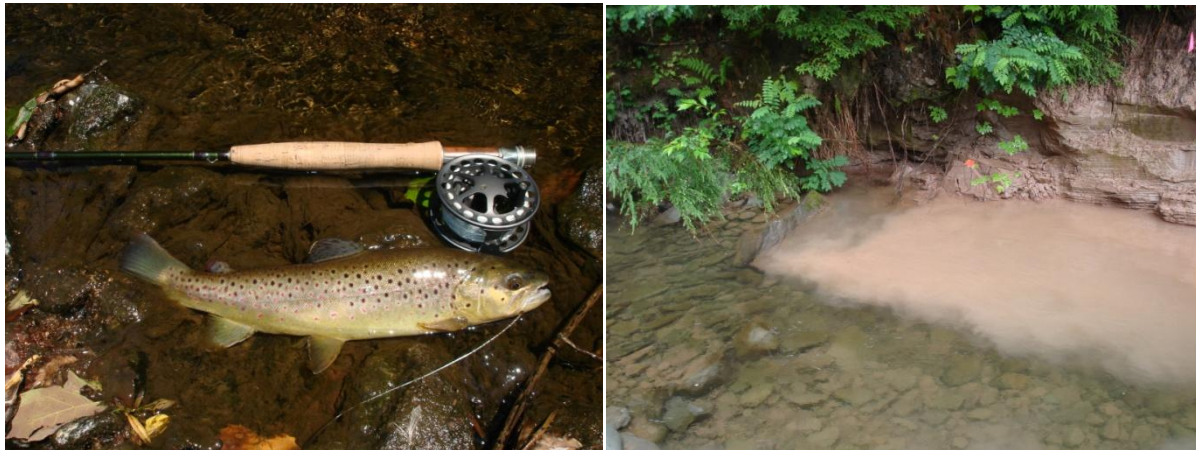
Figure 4(right): Exposed glacio-lacustrine clay deposits such as this are located throughout the upper Esopus watershed. Notice the increased turbidity once disturbed.

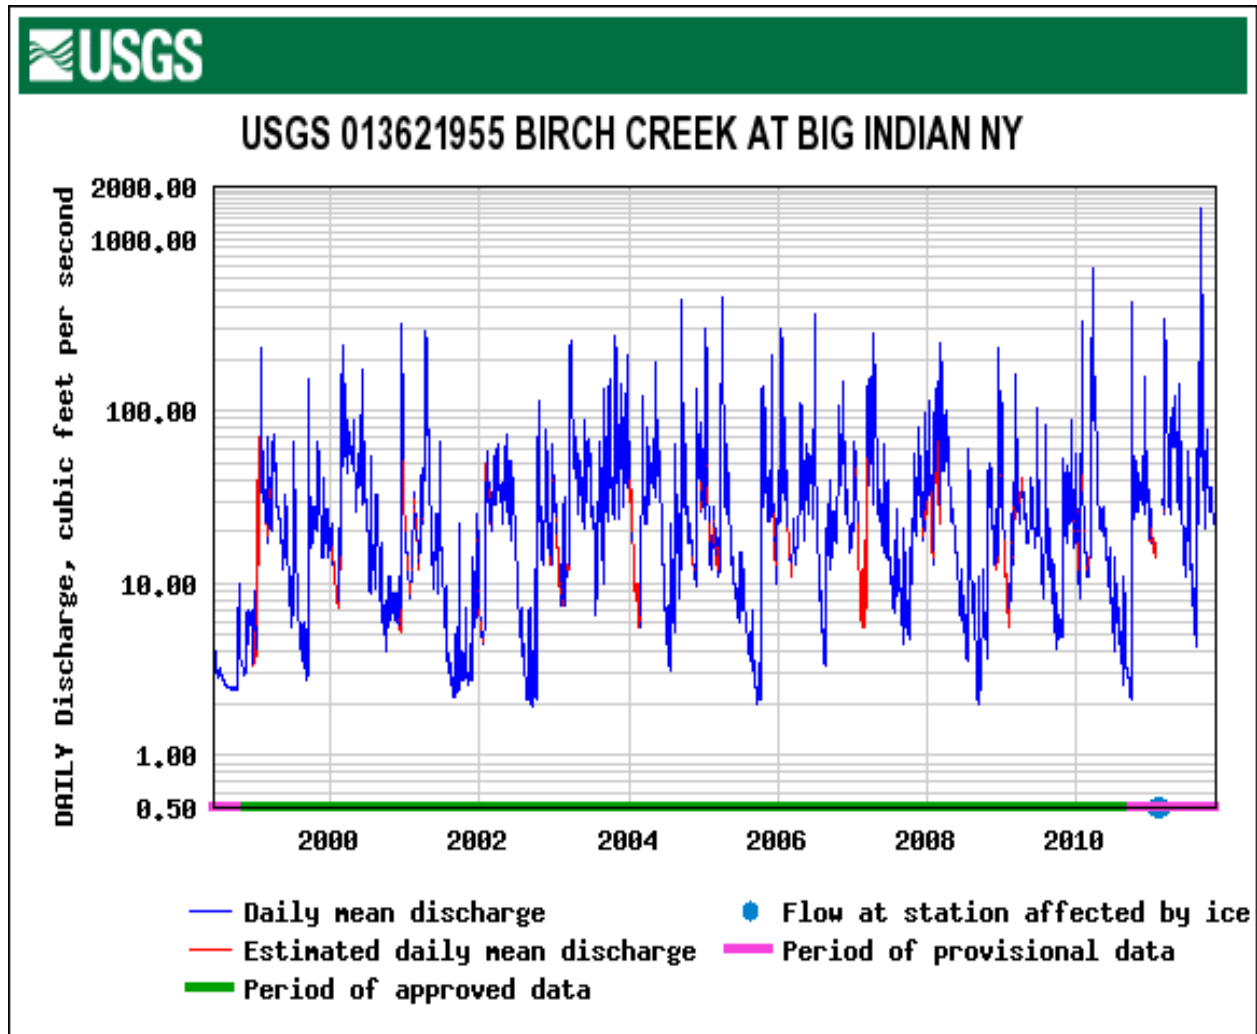
Figure 5: This hydrograph represents the continuous record from 1999 to the present at the USGS gauging station located on Birch Creek. The blue line represents real-time data with sharper increases and decreases in discharge (flashiness) as opposed to the red line representing daily mean discharge.

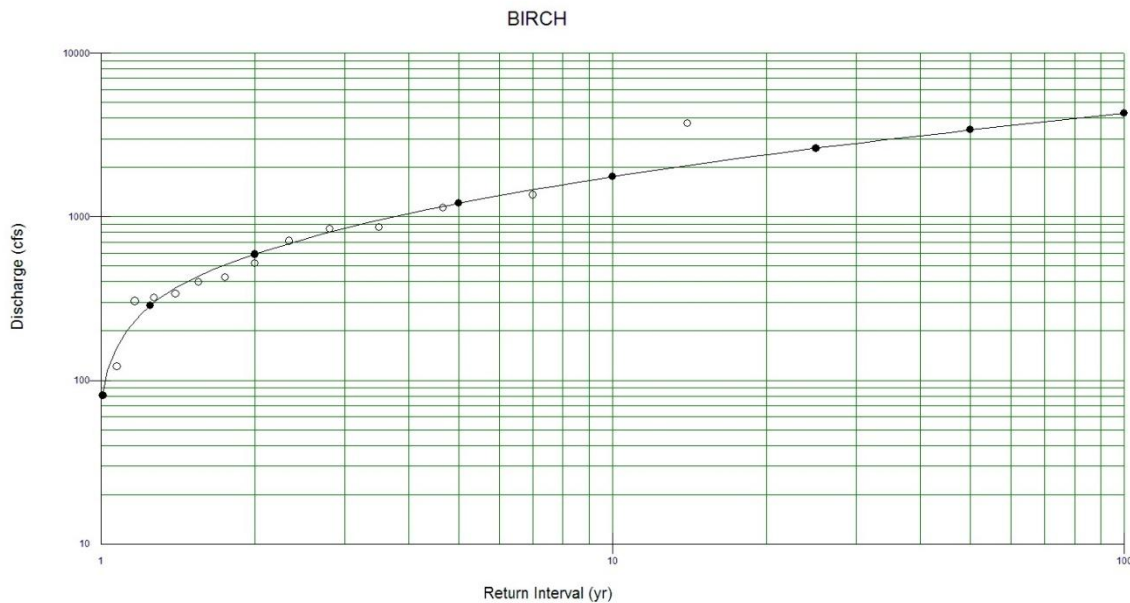
Figure 6: Log Pearson Type III distribution curve for recurrence intervals of peak annual discharges. Bankfull discharge (approx. 1.5 year interval) can be located on this distribution curve. The largest flow (Tropical Storm Irene) is located above the distribution curve because of the uncharacteristically (within the data set) large discharge with only 13 of record.

year was used to determine bankfull discharge. A corresponding discharge of around 410cfs can be approximated for the 1.5 year return interval (bankfull flow). The discharge during tropical storms Irene and Lee (3710 cfs) were significantly larger than the bankfull discharge.

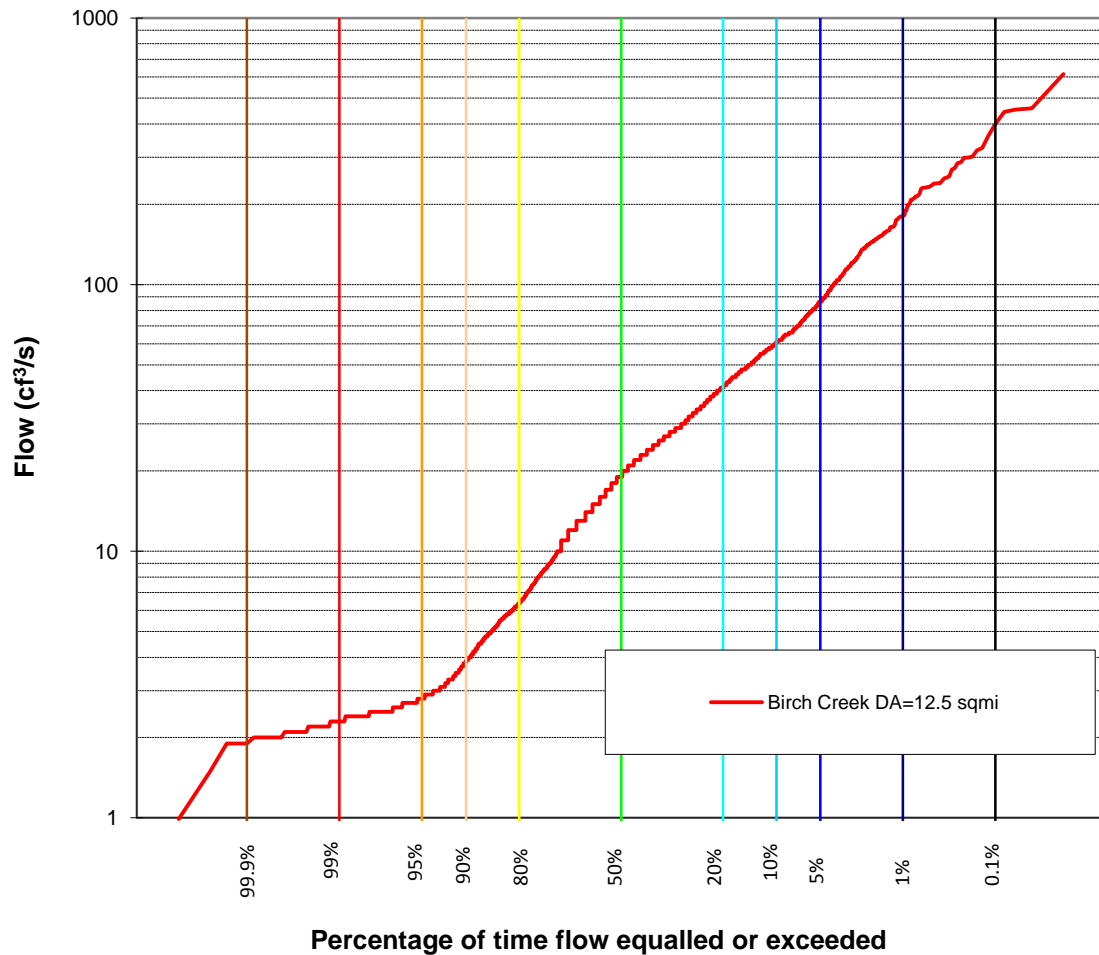
Figure 7: Daily flow-duration curves for Birch Creek based on USGS discharge data 1999-2010.

Figure 3 illustrates the daily flow-duration of Birch Creek from 1999 to 2010. A general trend depicting a uniform steepened slope was observed after flows exceed approximately 3 cfs. Flows below 3 cfs were depicted as a less steepened slope. The steeper slope above 3 cfs indicated a tendency for flashiness and smaller base flows. The flashiness may be attributed to rapid runoff in a steep gradient high relief mountain setting with limited shallow groundwater storage capacity. The less steepened slope or plateau below 3 cfs was observed less than 95% of the time, may be attributed to groundwater input during drought conditions. Flows equaling or exceeding 3 cfs occur at least 95% of the time.

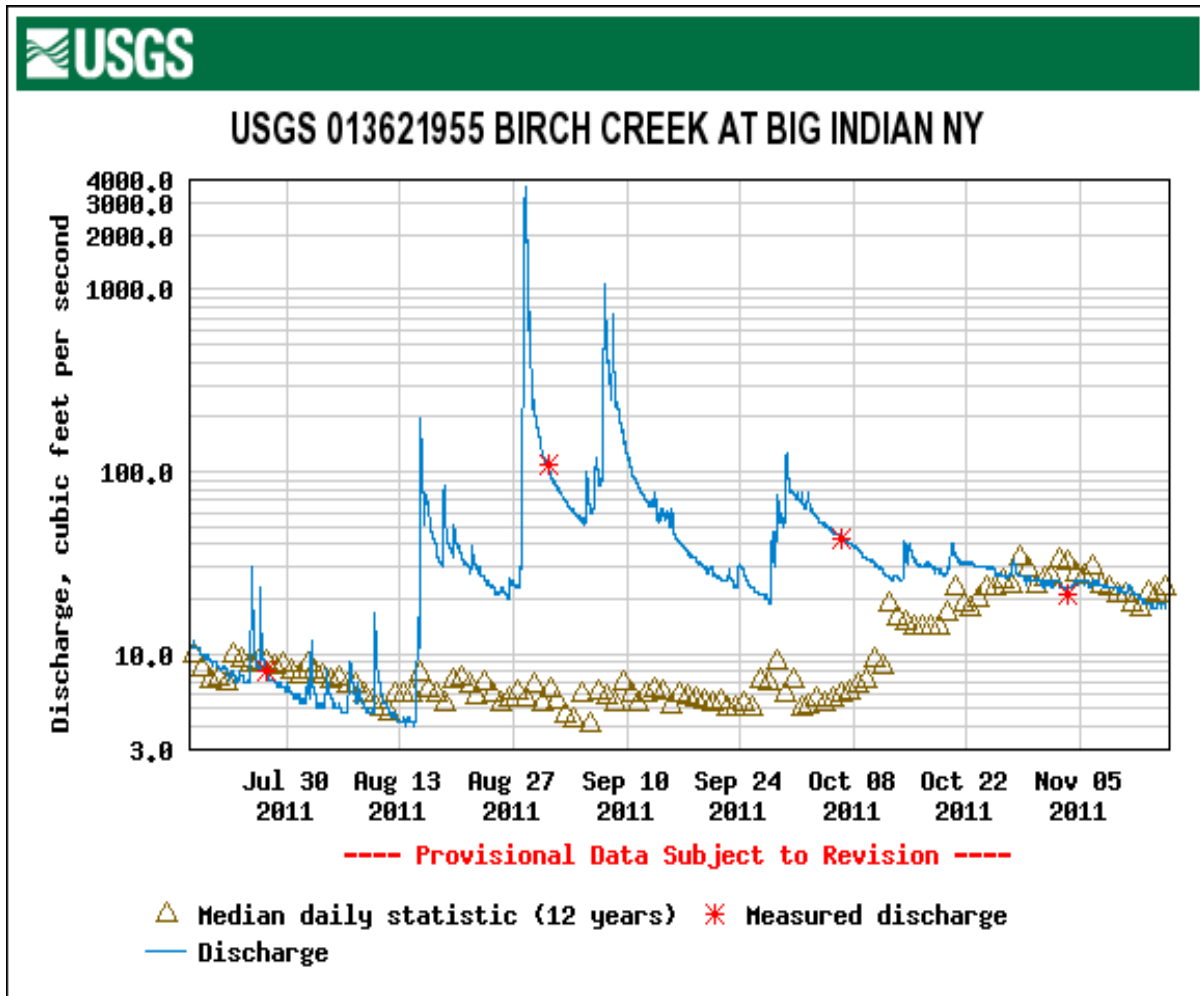
Figure 8: Hydrograph represents study period. The two largest discharges (3710cfs and 1060cfs) are representative of tropical storms Irene and Lee.

Increased localized precipitation and runoff rates were observed during the months of August and September 2011 by the occurrence of two tropical storms (Irene and Lee) passing through the Catskills region (Figure 7). Bankfull flows were exceeded approximately three times, with the largest being 3710 cfs (Figure 8). A proposal was developed in the spring of 2011 for the field season of July 2011 – October 2011. The first portion of fieldwork provided a baseline dataset was gathered pre-tropical storms Irene and Lee. Post flood assessments resumed late September to document geomorphologic changes after flood inundation.

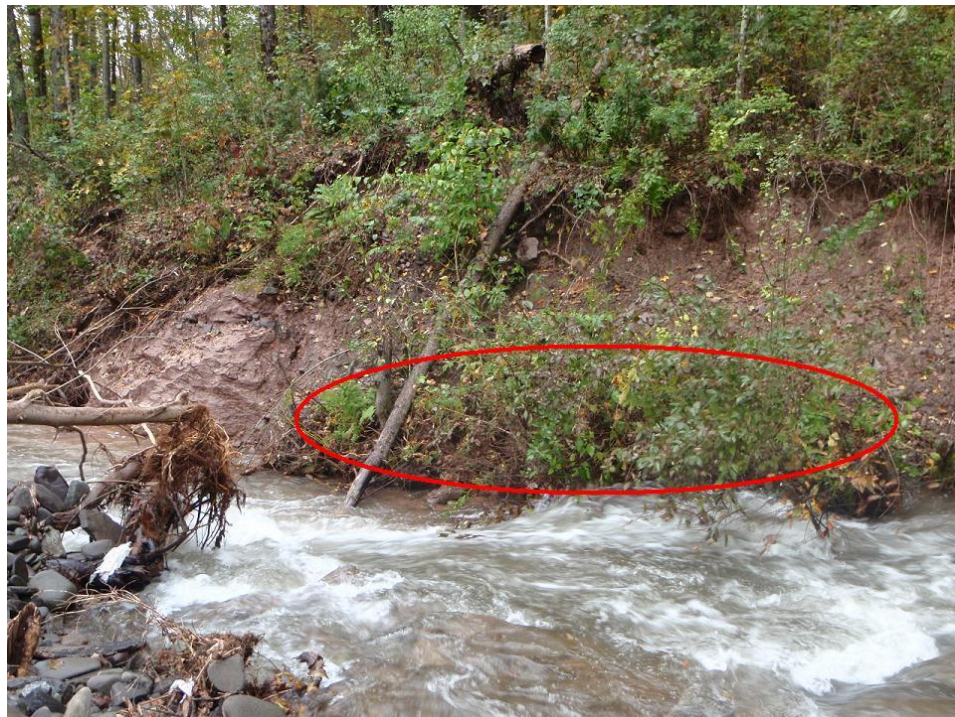
Figure 10: High erosive variability was observed in this type of non-alluvial boundary condition. Decreased shear strength after saturation from storms and removal of toe support initiated this geotechnical failure that created a shelf exposed below bankfull elevation. The red circle illustrates the section of vegetated-glaciolacustrine clay layer that slumped near the water surface.

The BANCS model erosion rates were developed in intermountainous alluvial settings, tailored for Southern Colorado and Yellowstone. The relations developed from Colorado and Yellowstone are not intended to be universal for alluvial streams (Rosgen 2008a). It was unclear if non-alluvial boundary conditions such as glacial till and/or glaciolacustrine lake clays observed in the Catskill region may influence the erosion rates in ways that may not be predicted by the BANCS model. Mass failures are thought to be initiated by the presence of clayey bank material because of the clays ability to retain water, causing an increased mass and concurrent decrease in shear strength (Abbott, 2004) (Figure 5). In particular, banks composed of glacial till and/or glaciolacustrine lake clays have been observed to experience geotechnical failures, in which the bank slumps but maintains a vertical profile creating shelf typically being exposed even at base flow elevation. This shelf can skew the amount of material removed (deposition as opposed to erosion) and off-set the corresponding high BEHI rating. These exposed glacial deposits yield suspended sediment at flows that would not normally entrain alluvial material.

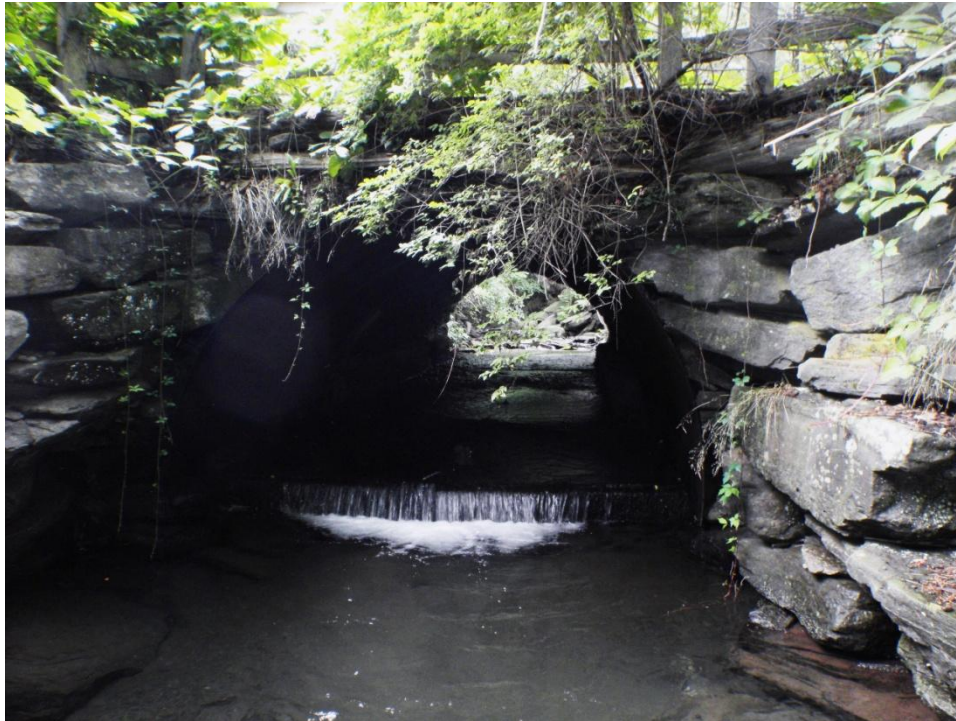
Figure 11: The observable section of stream has been straightened and constricted, conveying flow through a culvert and stacked rock walls to protect roadway infrastructure.

Many locations throughout the upper Esopus Creek have been treated by mitigation and restoration efforts. The most common reasons for installing revetment are decrease flood and erosion hazards around private property or public infrastructure. Armoring the bank can often cause changes in stream geometry. The highest velocity within the stream can be displaced elsewhere such as upstream and more frequently downstream, often causing channel scour and bank erosion. During peak discharges of tropical storms Irene and Lee, many of the undersized conveying or contributing bridges and culverts created channel constrictions or blockage upstream of the infrastructure. These structures created depositional environments for large woody debris and sediment and in turn, experienced increased amounts of erosion and or channel avulsions, which may not be accurately assessed with the BANCS model. Once stream banks have been armored the erosive potential of the bank cannot be predicted when applying the given variables in the BANCS.

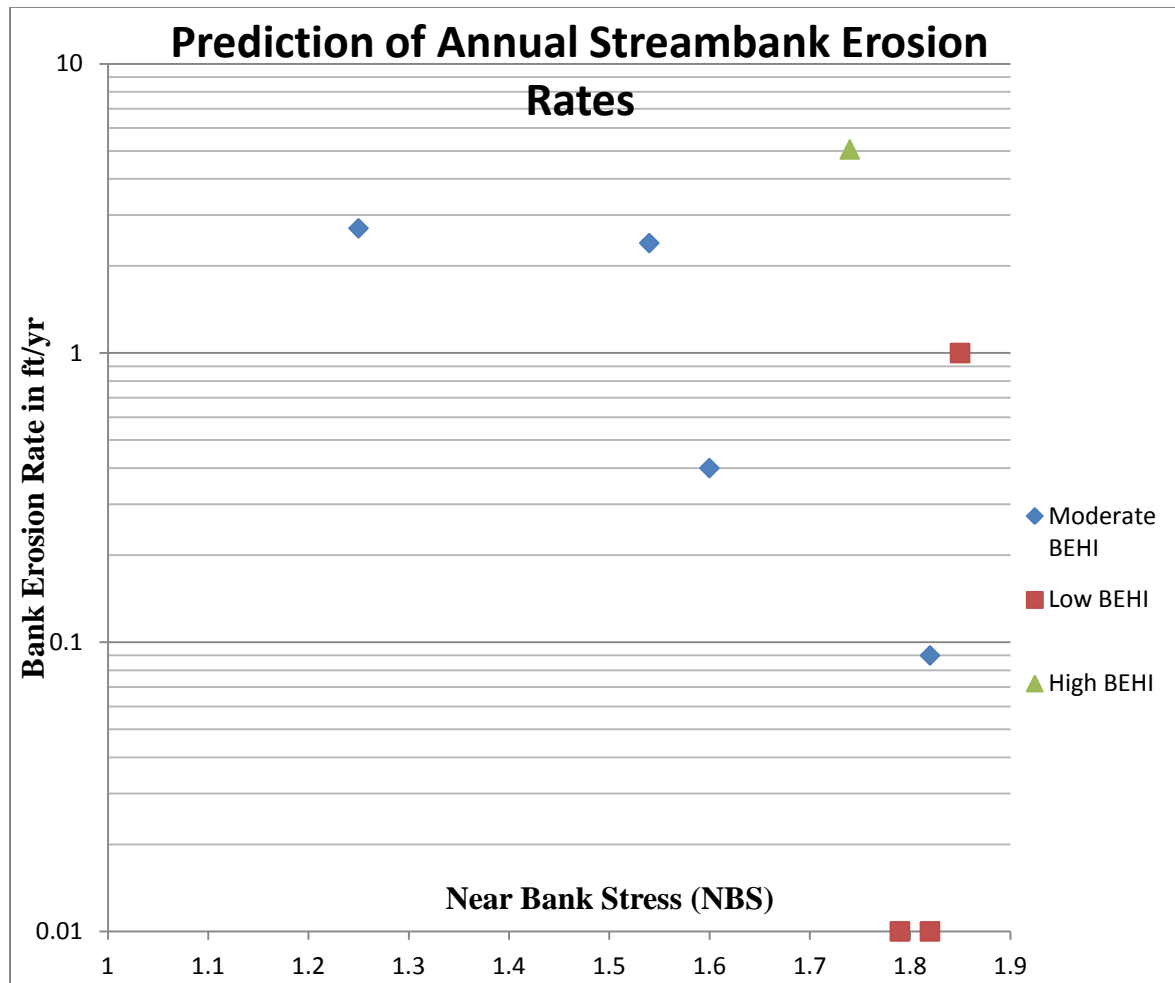
Figure 12: The Birch Creek NBS and BEHI ratings are plotted against measured erosion rates. Areas that experienced deposition were plotted as 0.01 because negative values could not be plotted on a logarithmic scale. Birch Creek did not produce a curve to plot measured bank erosion rates respective to their BEHI and NBS ratings.

NBS ratings, and material removed have been plotted to determine if an erosion rating curve can be developed from a total of nine data points (Figure 13). In addition, BEHI and NBS ratings were plotted separately against material removed (Figures 14 and 15). Furthermore, all 144 assessed sites including the monumented cross sections were projected for a watershed analysis of both BEHI and NBS ratings; comparisons of each erosive potential ratings can be observed in Figure 16.

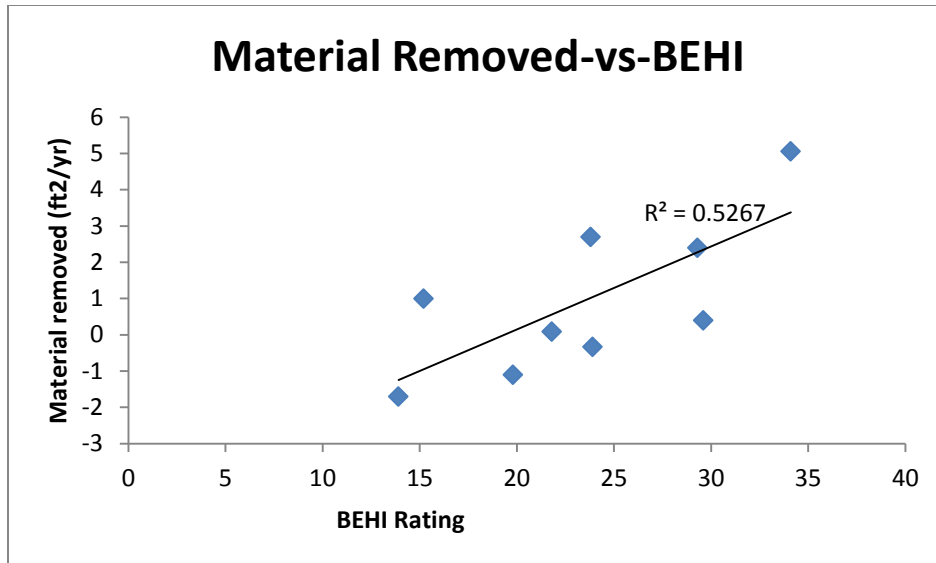
Figure 13: BEHI ratings from all monumented cross sections were plotted separately against material removed. Negative values on the y-axis represent deposition. Some scatter was observed. An overall correlation between material removed and BEHI was graphed ($r^2=0.5267$).

BEHI and NBS ratings were plotted separately against material removed to identify any correlated trends in the data. No trend was observed in the NBS graph, suggesting as measured in the field, NBS was potentially not a sound erosion predictive model for the Birch Creek watershed for our study. For this project to assess Birch Creek, one method was employed to calculate NBS for all of Birch Creek. The NBS method and numerical ratings were based solely on Rivermorph for NBS calculations. There were seven possible ways to assess near bank stress, however only one was chosen to encompass all geomorphic characteristics of Birch Creek. The ratio of near-bank maximum depth to the bankfull mean depth method for determining NBS was the only method used in order to maintain consistency.

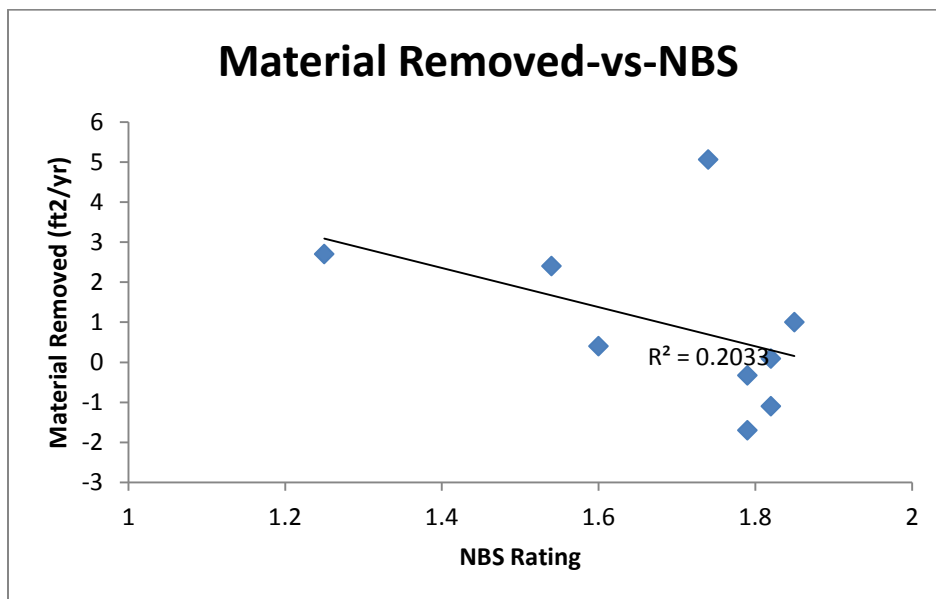
Figure 14: NBS rating from all monumented cross sections were plotted separately against material removed. Negative values on the y-axis represent deposition. Considerable scatter was observed. An overall correlation between material removed and NBS was graphed ($r^2=0.2033$).

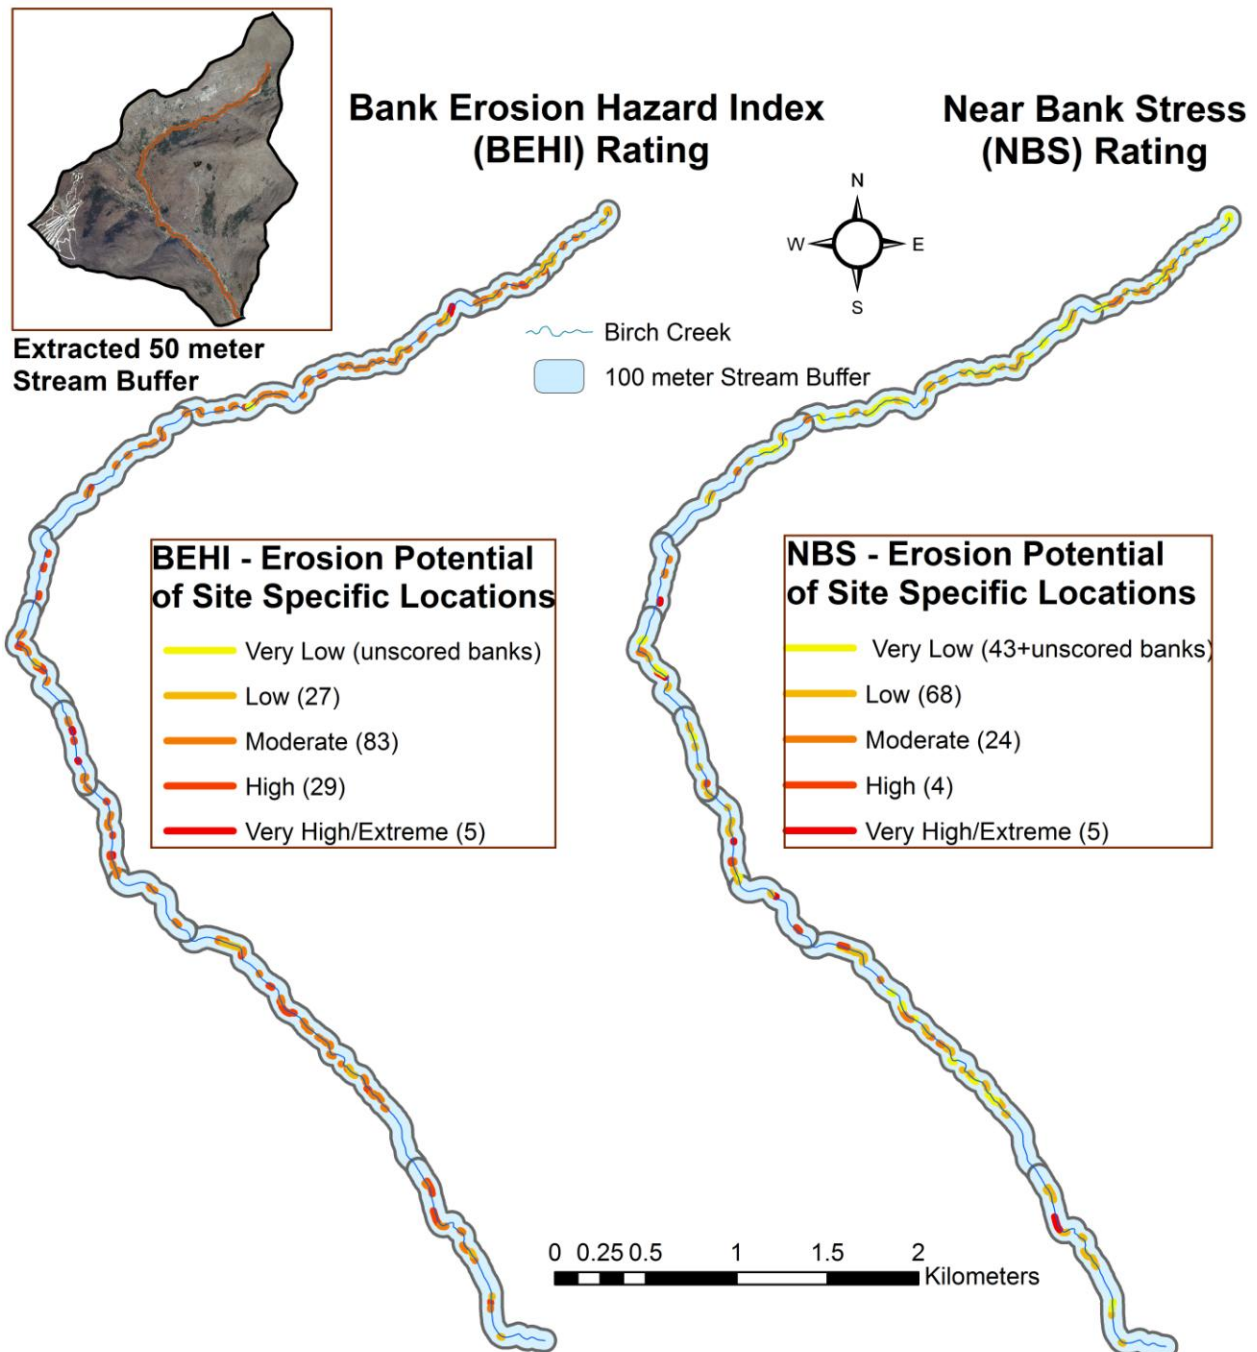
Figure15: Stream Buffer layout of Birch Creek erosion analysis indicating site specific BEHI and NBS ratings. A total of 144 sites were assessed. All banks that were not assessed during this study were considered stable and would have reflected very low BEHI and NBS ratings. Outline (grey line) represents a buffered zone surrounding the entire length of Birch Creek (blue line), Colored areas represent BEHI and NBS scores respectively.

Higher near bank stress ratings often indicate a higher erosion rate along the bank (Rosgen, 2001), which was not observed in table 2 and figure 15. For instance, the assessed banks at the upstream monumented cross section in reach 11 corresponded with a high NBS rating, as the thalweg was observed in the center of the channel and no apparent shear stress was on the banks. This particular method, which used the ratio of max bankfull depth to mean bankfull depth, may have been a better predictor for areas that were not steeply sloped or uniformly entrenched such as reaches 11 or 2. Because the same cross section was often used to assess adjacent stream banks, the NBS ratio was therefore applied to both banks. In some cases both stream banks along the channel were scored and rated with independent BEHI ratings but given the NBS rating. Other NBS methods may have produced a more accurate rating for the observed erosion rates because that particular method was independent of thalweg location within the stream channel.
