DIAGNOSTIC ASSESSMENT OF WARNER CREEK, CATSKILL MOUNTAINS, NY - THREE YEARS OF STUDENT CONDUCTED RESEARCH: CONCLUSIONS AND IMPLICATIONS

W. Danyelle Davis (NYCDEP)

Christopher J. Callinan (Clarkson University)

Geological Society of America Northeastern Section

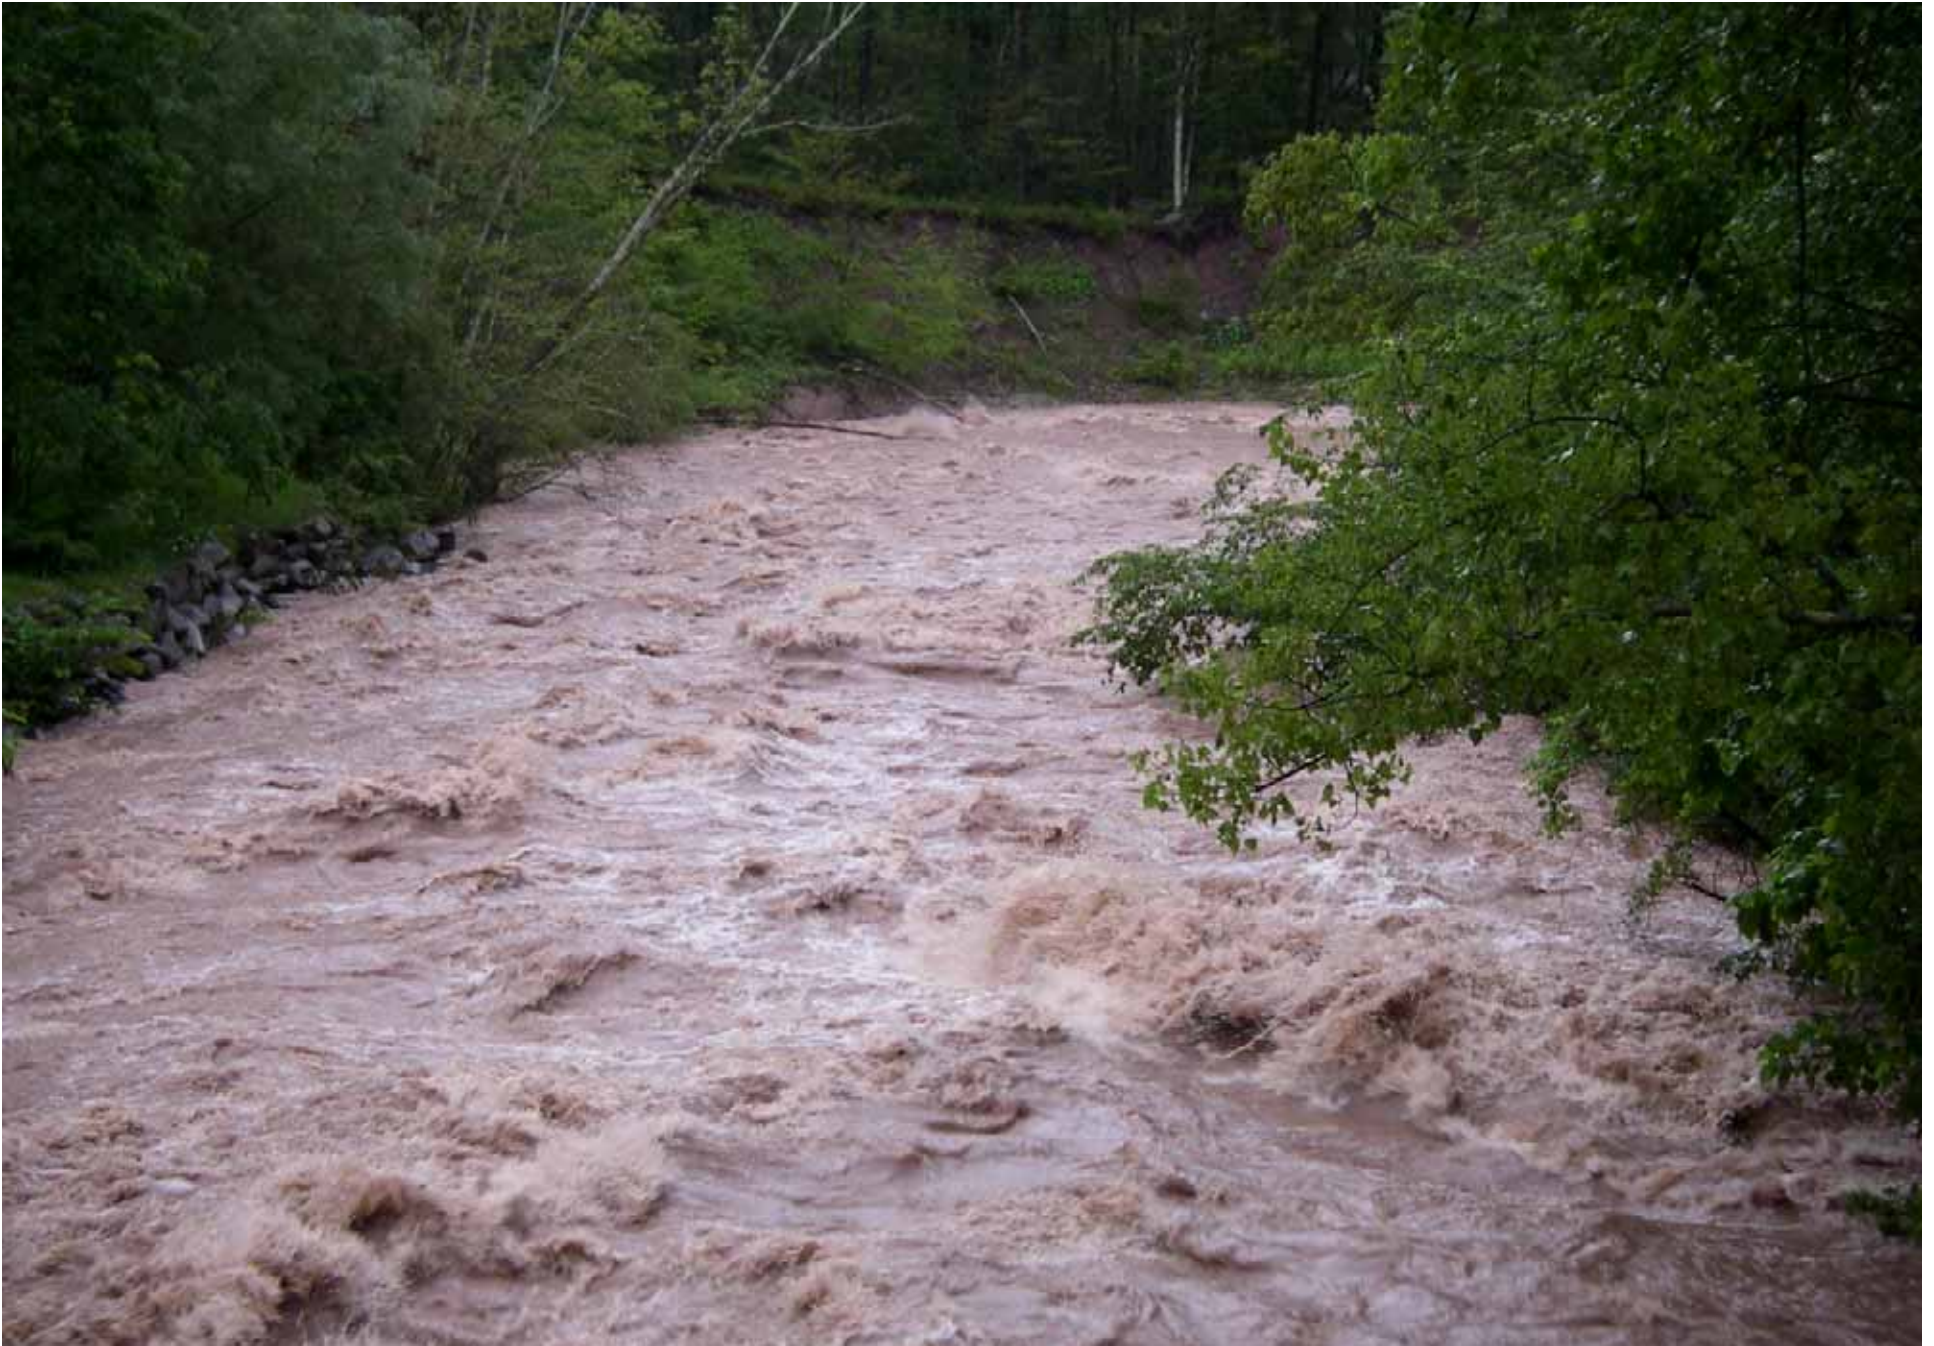
Esopus Creek at Coldbrook, NY (USGS Gage #01362500)
Annual Peak Flows, 1933 - 2011

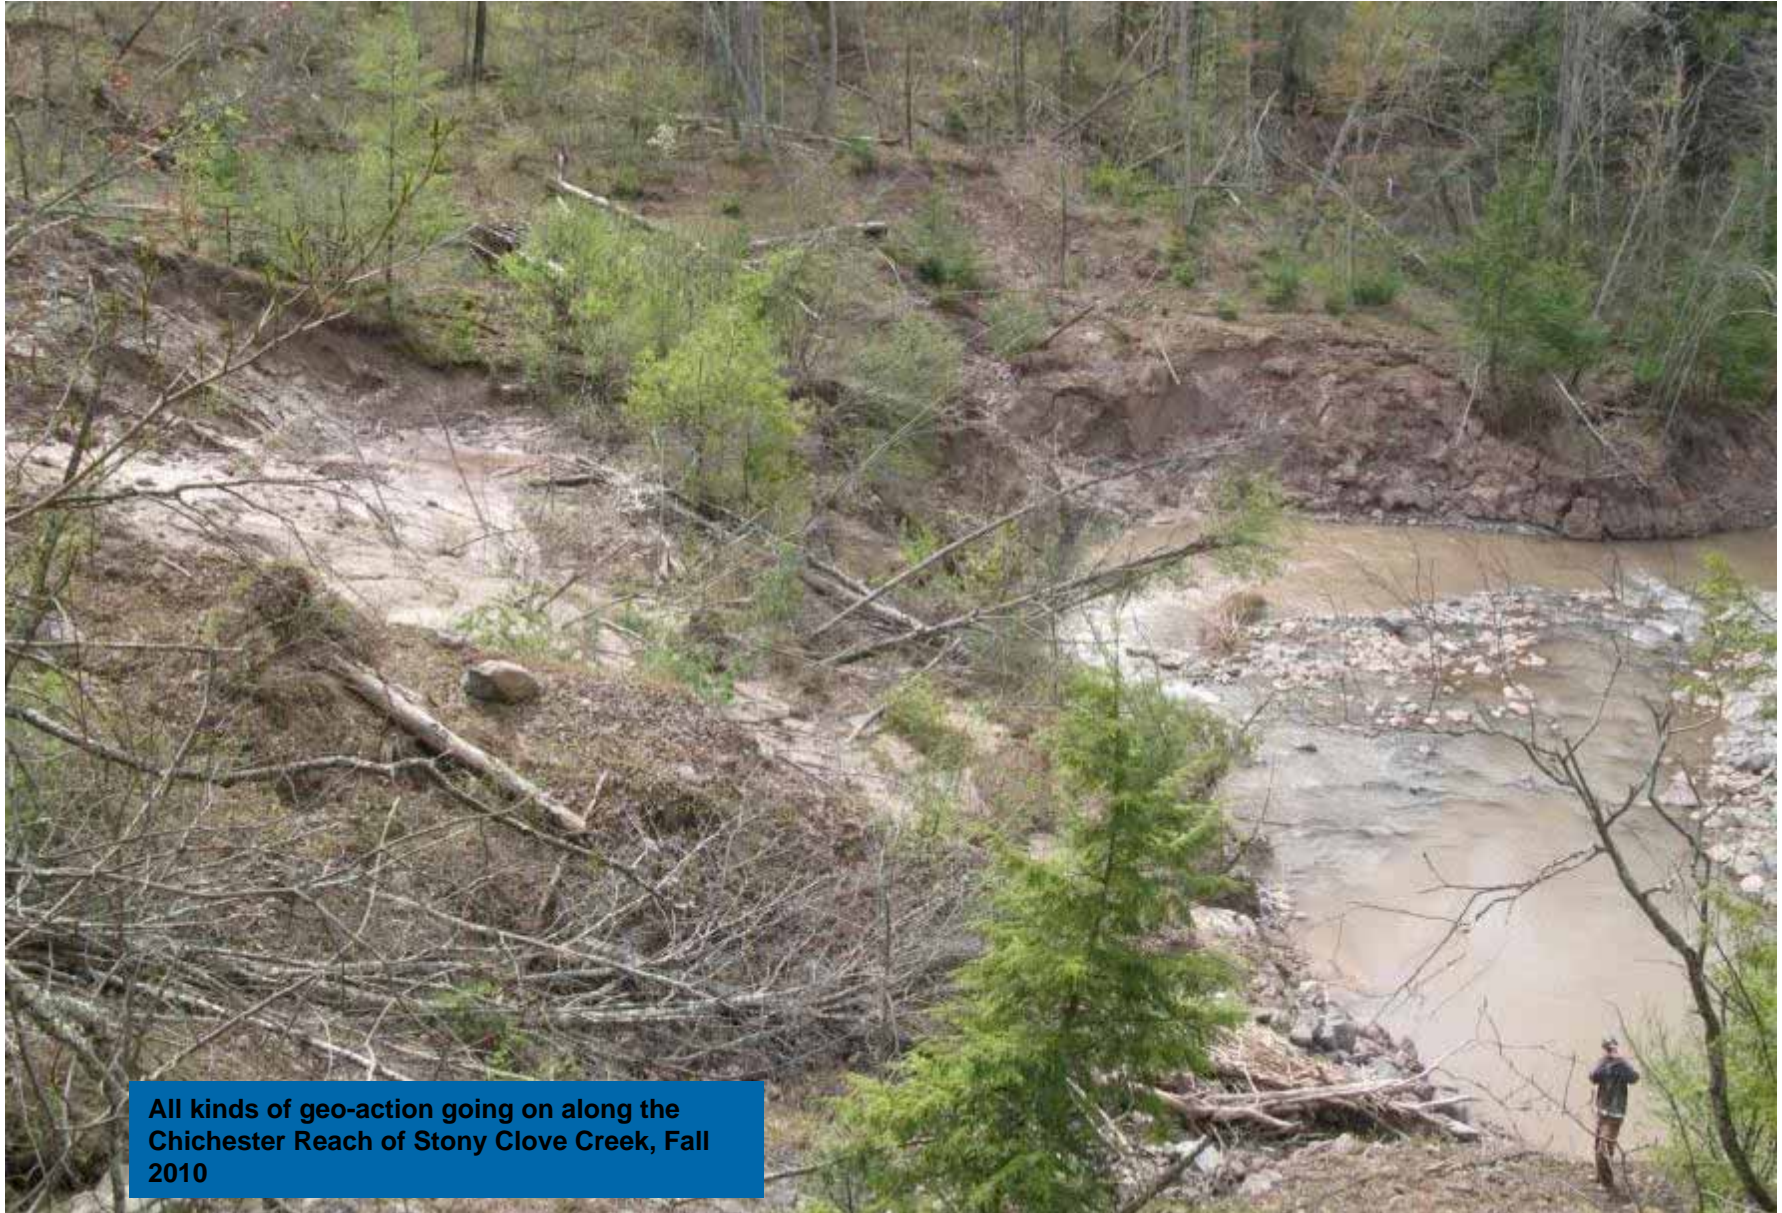
All kinds of geo-action going on along the
Chichester Reach of Stony Clove Creek, Fall
2010

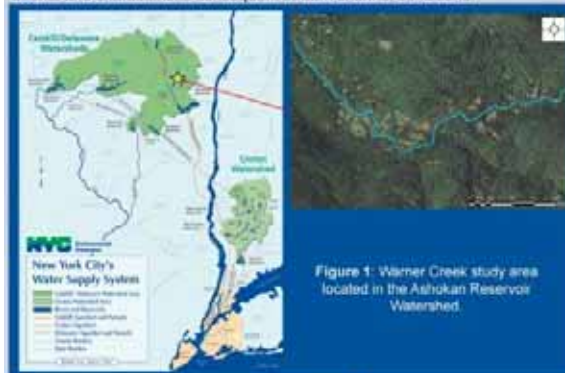
Figure 1: Warner Creek study area located in the Ashokan Reservoir Watershed.

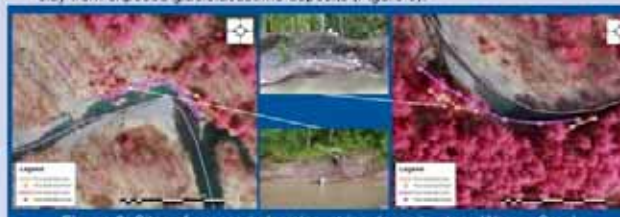
Figure 6: Sites of exposed glaciolacustrine deposits along Warner Creek

- Stream bank and adjacent hill slope erosion account for most of the coarse and fine sediment loading based on the observed increase in erosion and deposition from 2010 to 2011 (Figures 5 - 8).
- The calculated volume of sediment eroded from the banks in the reaches studied was 4,260 m³ between the summers of 2010 and 2011.
- Observed chronic turbidity in Warner Creek originates from entrainment of silt and clay from exposed glaciolacustrine deposits (Figure 6).

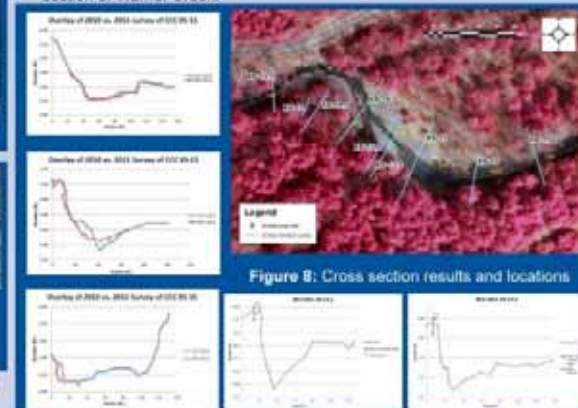
- Bank profiles and channel cross sections were done in the forest avulsion section of Warner Creek.

Figure 8: Cross section results and locations

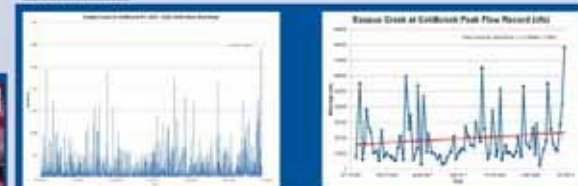
Figure 9: Mean daily discharge and peak flow record hydrographs (D. Davis)

- Warner Creek is responding to a changing hydrologic regime (Figure 9).
- There is no apparent net increase in mean annual runoff, however there is an increasing trend in the frequency of annual peak flows greater than bankfull discharge (as determined for Esopus Creek based on 80 years of USGS stream gage data).

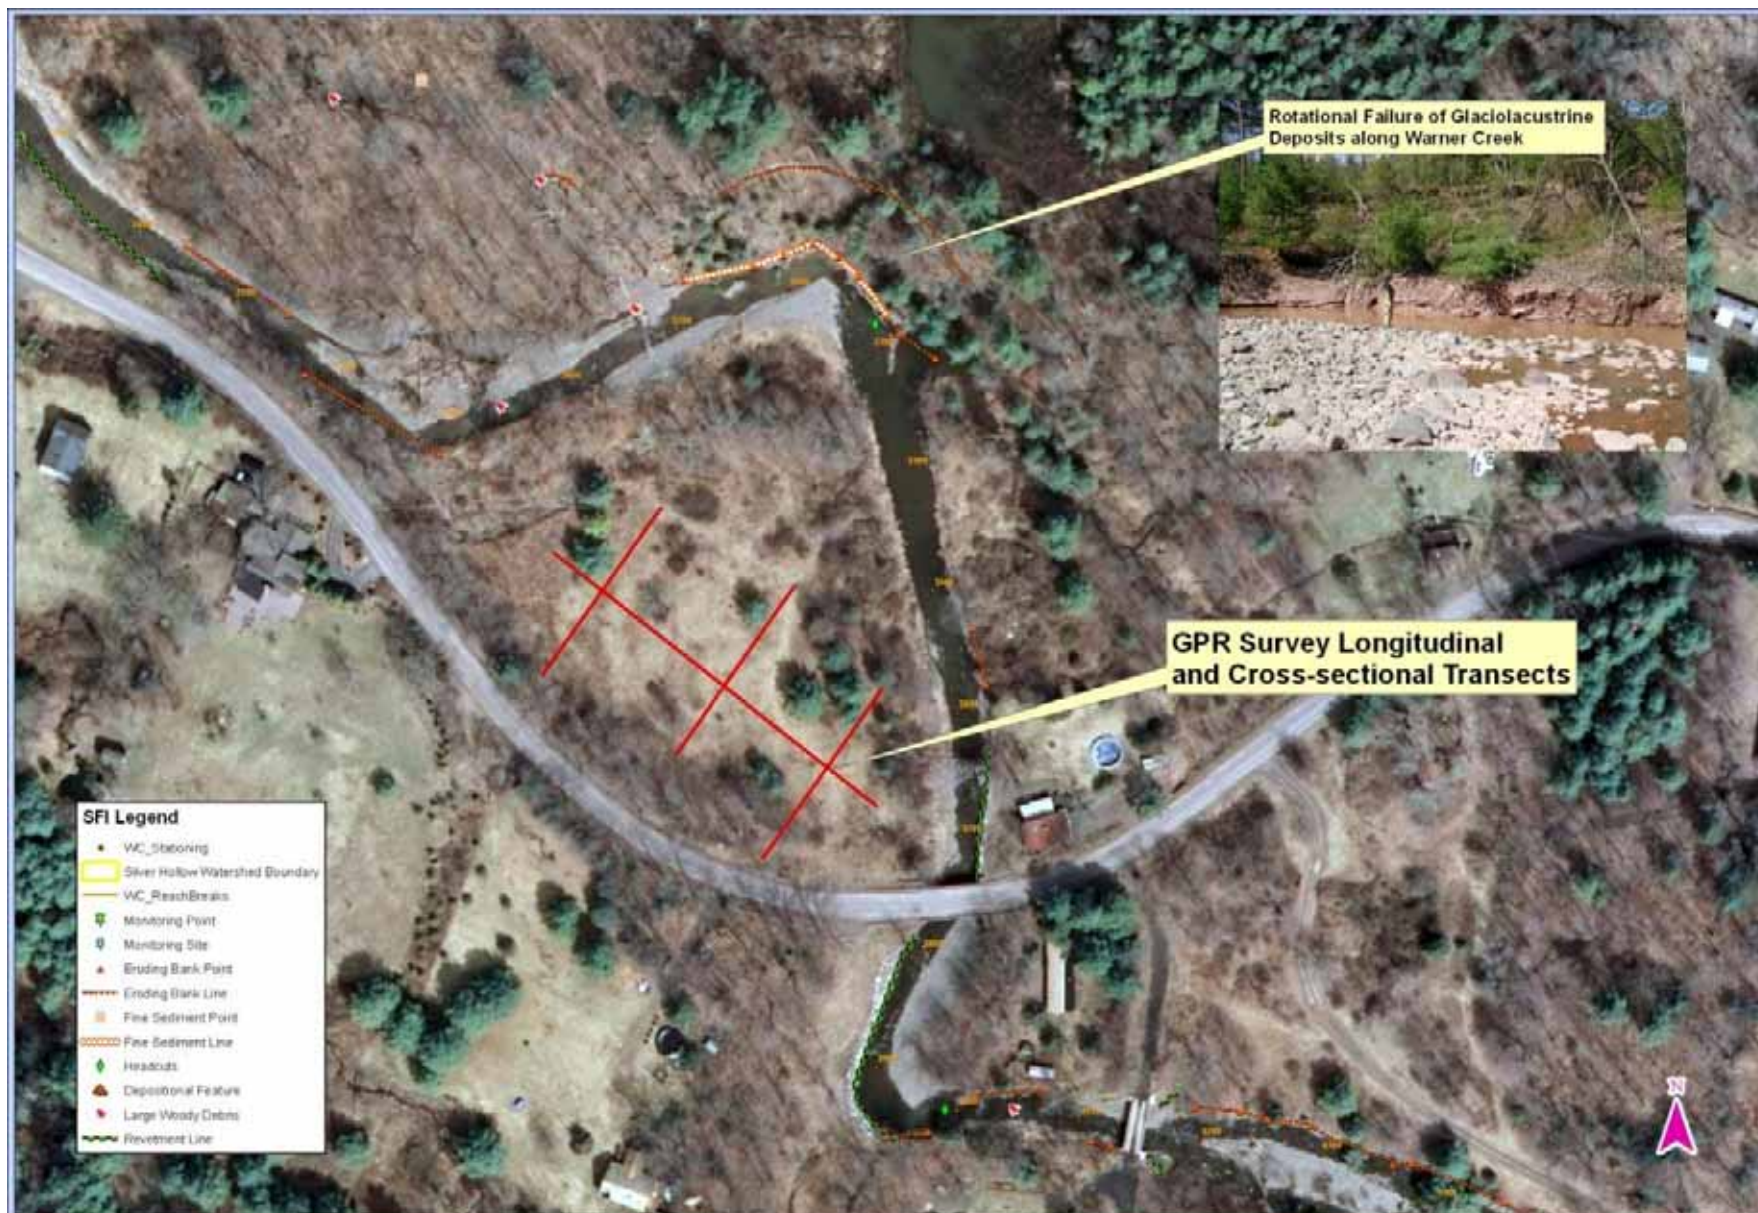
Ground-Penetrating Radar Survey Adjacent to Warner Creek Reach 12 (July, 2010)

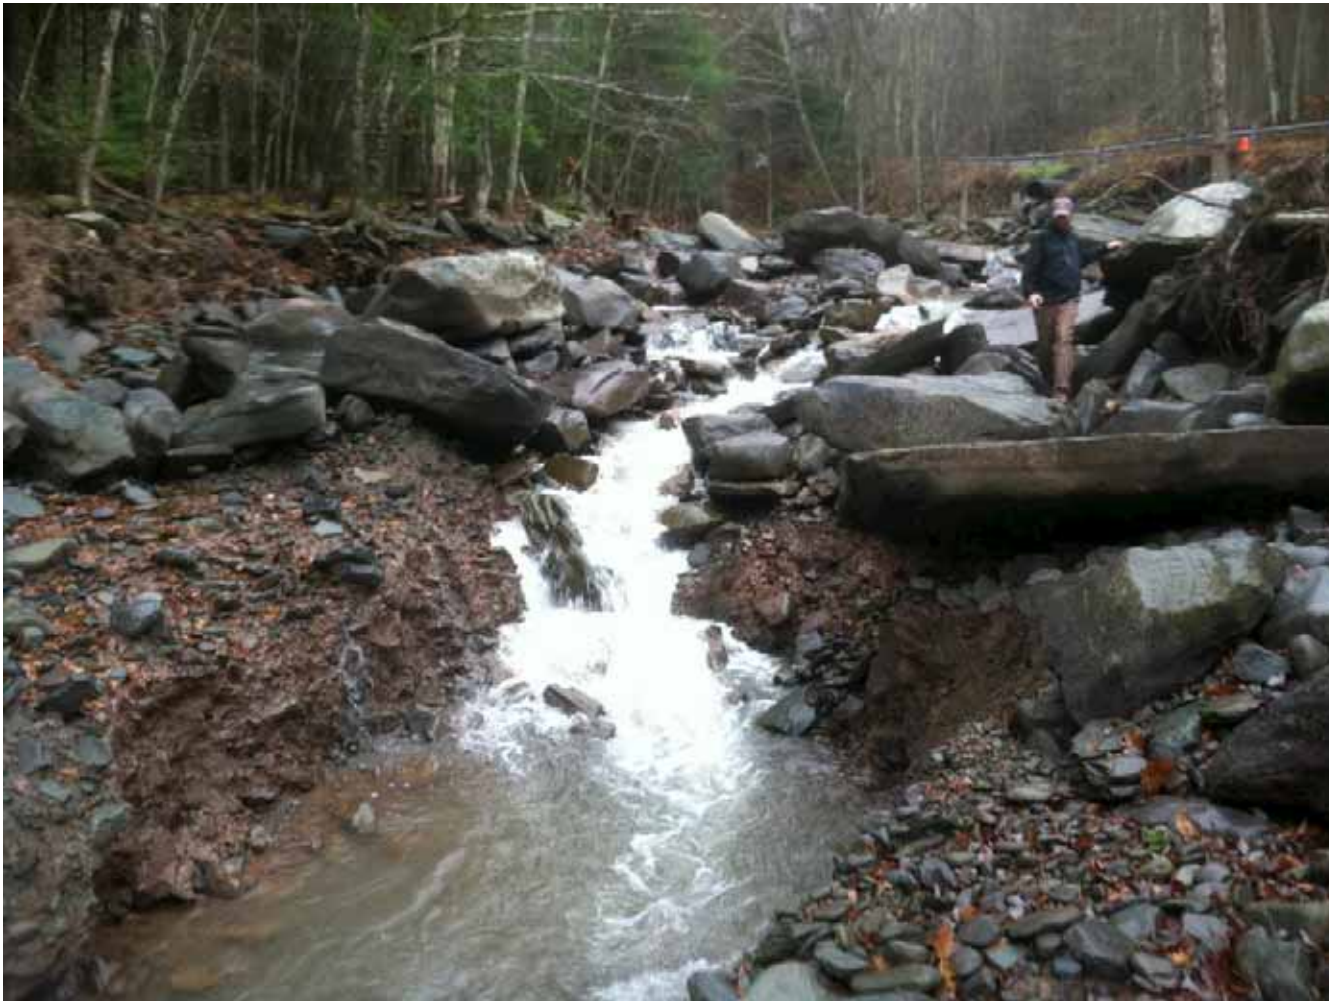
Warner Creek/Stony Clove Creek Confluence: Headcut Mitigation
