# Esopus Creek NEWS

PUBLISHED BY CORNELL  
COOPERATIVE EXTENSION  
ULSTER COUNTY

## 11-YEAR FLOOD ON CHRISTMAS DAY

Esopus Creek  
NEWS  
WINTER  
2021  
Cornell Cooperative Extension of Ulster County  
232 Plaza Road  
Kingston, NY 12401

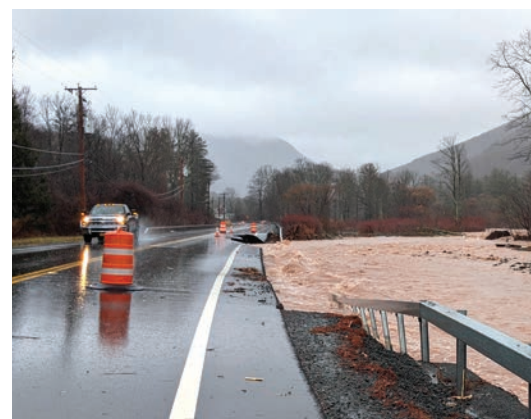
High flows in the Stony Clove Creek on Christmas Day caused the temporary closure of State Route 214 near Lanesville. The NYSDOT is overseeing repairs. Photo by Dany Davis

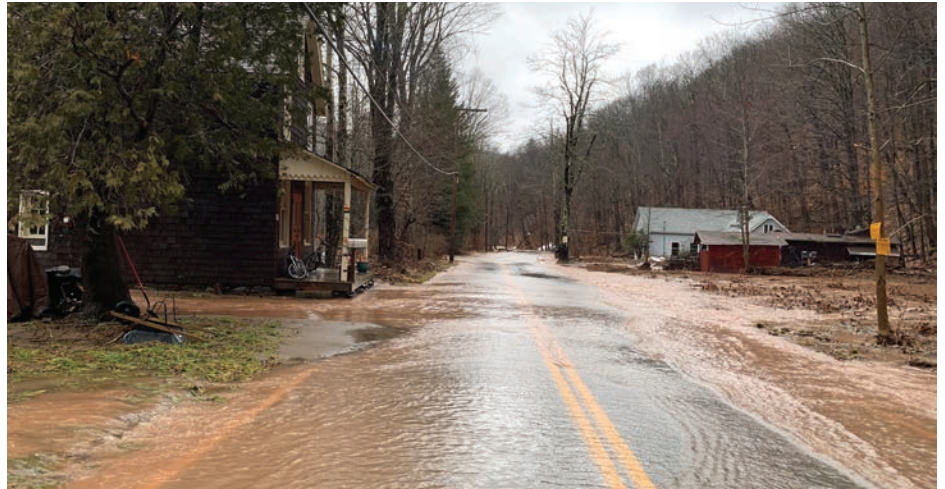
*Flooding near homes along the upper Esopus Creek on Christmas Day 2020. Photo by Aaron Bennett*

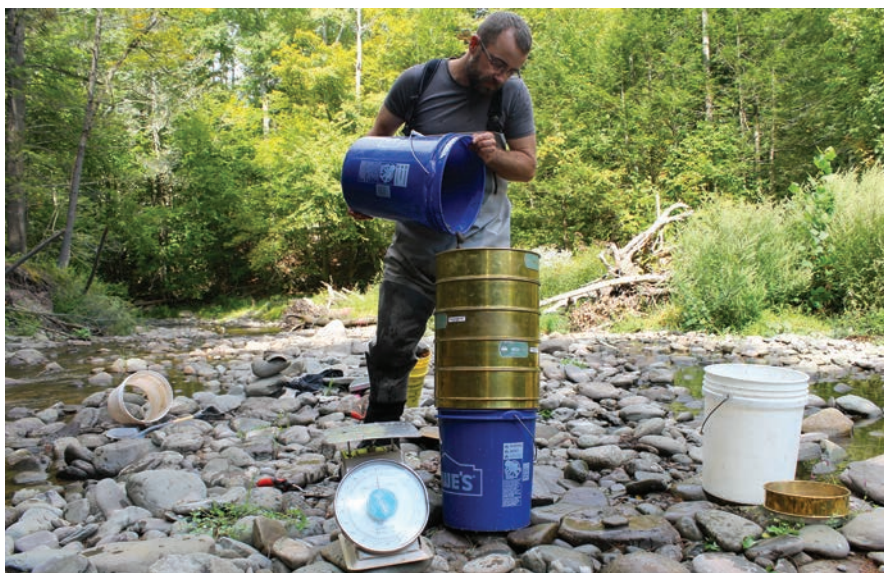
*Sediment sampling at one of two Warner Creek stream restoration sites slated for construction in 2021. Extensive survey, design and engineering were completed to prepare for construction.*

Work is planned at two sites on Warner Creek near Silver Hollow Road in the Town of Shandaken. The sites are located off the road in wooded areas 1.2 and 1.5 miles upstream from where Warner Creek empties into the Stony Clove Creek.

Erosion at the sites has been monitored since flooding in 2010. During the flood, Warner Creek cut a new path through clay-rich soil deposits left behind by glacial lakes. About 1,100 feet total of stream corridor will be restored to a more stable configuration that removes stream flows from contact with the glacial lake clays.

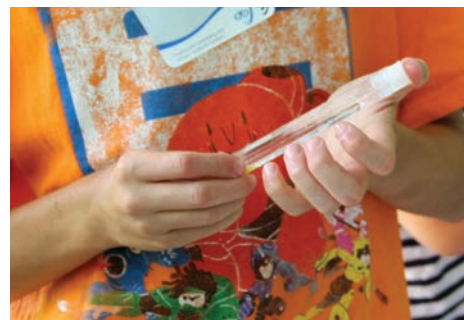
Scientists at the U.S. Geological Survey (USGS) are the nation's experts in monitoring stream flow and water conditions. Because of its status as a large drinking water supply, the Ashokan Reservoir watershed has one of the most extensive USGS monitoring networks in the state. The USGS studies the amount of fine sediment suspended in local stream flows and tracks how much sediment is coming from different tributary streams.

Monitoring between 2018-2020 indicated a pattern. The tributaries contributing the most amount of fine sediment during this time were Woodland Creek, Stony Clove Creek, and the Beaver Kill. These tributaries produced the highest concentrations of sediment and the highest loads of sediment to the mainstem Esopus Creek.

The creeks do not all behave the same way however. The Beaver Kill is a cleaner stream during low flows and only becomes highly turbid at higher flows. The Birch Creek, Woodland Creek, and Stony Clove Creek sustain high levels of sediment per unit of streamflow during a range of stream flows. But, Birch Creek doesn't make the list of top-sediment contributors because its watershed contributes a smaller amount of flow compared to the others.

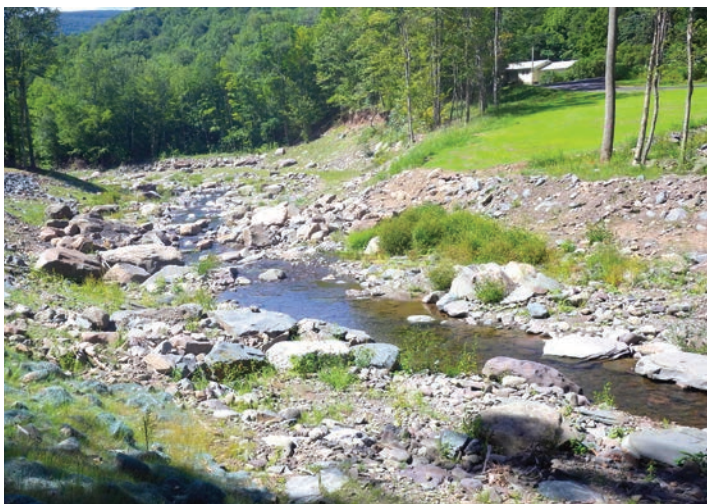
*Wright Road stream restoration project shortly after project construction ended in 2016.*

The transformation can be remarkable in just a few short years. The photos at the bottom of page 5 show a stream restoration project on the Stony Clove Creek near Wright Road in Lanesville. The left photo is the project shortly after construction in 2016. The right photo is the site in 2020 during a survey five years after construction. In another five years, the site will look even greener and shaded. The perfect hangout for a large trout.

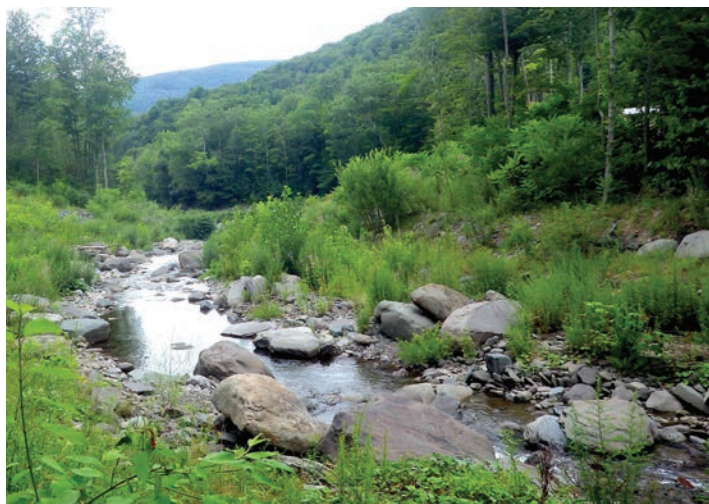
*Wright Road stream restoration project after five years of vegetation regrowth and a few high flows in 2020.*

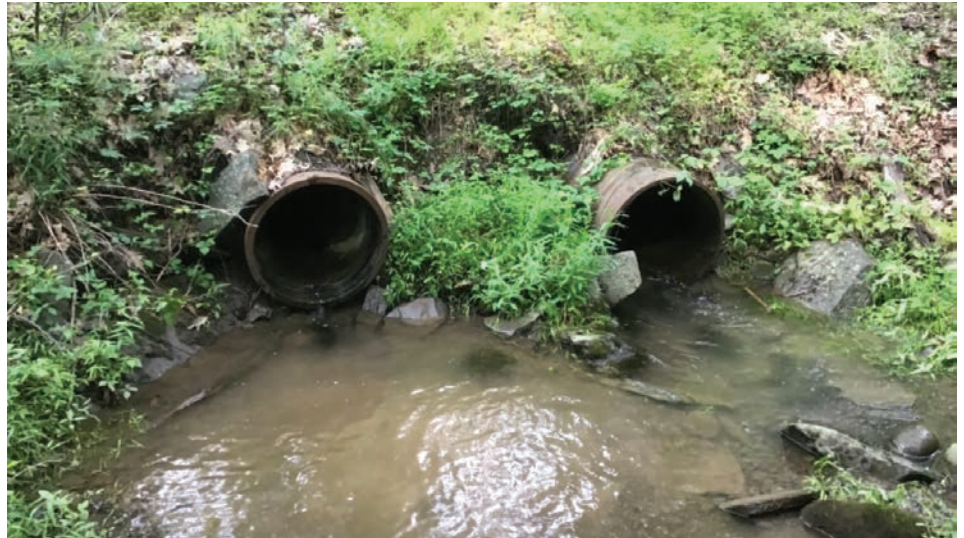
*A scour pool beneath two under-sized culverts with evidence of erosion.*

One common way undersized culverts worsen flooding is by eroding the stream at the downstream end of the culvert. Erosion can be so severe that a scour pool forms directly beneath the outlet of the structure. Scour pools form when the water traveling down the stream channel is suddenly squeezed into a smaller path (by the undersized culvert) and effectively becomes a funnel. As the cross-sectional area of the stream decreases, the velocity of the water increases and then gets 'shot' out at the outlet of the structure. The deepened scour pool then causes the stream banks to become steep and unstable. That often leads to erosion of the road or nearby land.

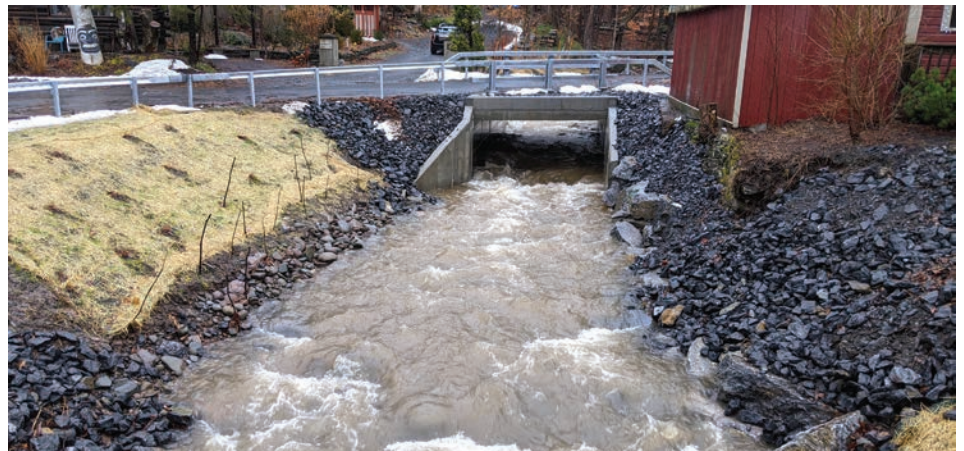
*An upsized culvert on DeSilva Road constructed by the Town of Olive in late 2020 performed well during the Christmas Day flood. Photo by Ethan Ely*

In addition to erosion, sometimes the hydraulic capacity of the undersized culverts is exceeded during high flows. The water level of the stream increases and then can overtop the structure - making the road impassable. This is more likely to occur when the culverts are clogged by sediment and wood carried by stream flows. Furthermore, as our climate is changing, the Catskills are receiving more rain than ever before. This only amplifies the urgency for installing culverts that are not undersized.
