# Esopus Creek NEWS

PUBLISHED BY CORNELL  
COOPERATIVE EXTENSION  
ULSTER COUNTY

## RESTORING WARNER CREEK TO A HEALTHIER STREAM

Esopus Creek  
NEWS  
SUMMER  
2021  
Cornell Cooperative Extension of Ulster County  
232 Plaza Road  
Kingston, NY 12401

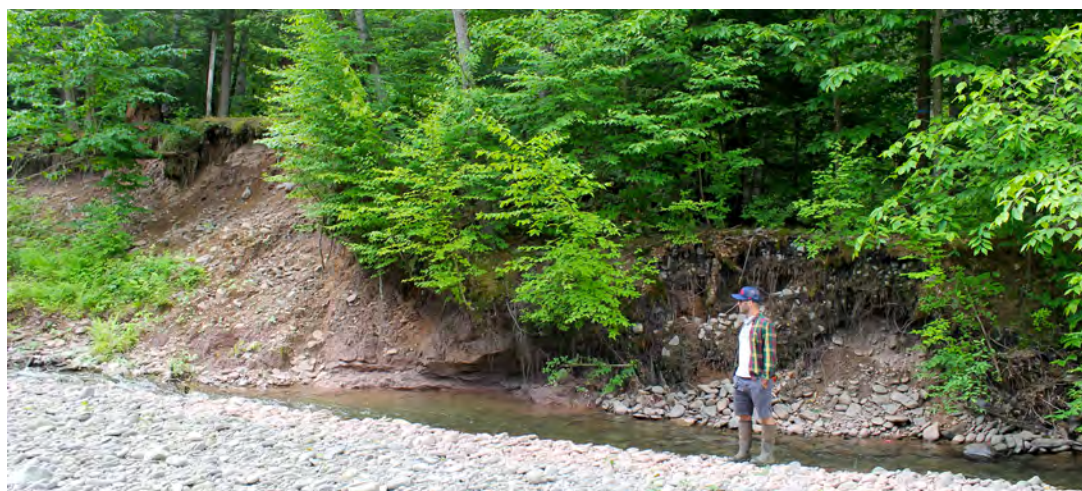
*Floods caused the Warner Creek channel to shift into a previously forested floodplain. Once stream flows began cutting into finely textured soils, the sites became a water quality concern.*

*The creek inhabited by fish needing cool water to survive, is now running shallow over heated rocks at the sites.*

When the stream program began monitoring the sites a person could easily hop across the creek, but 10 years later the channel has widened to more than three times its original width.

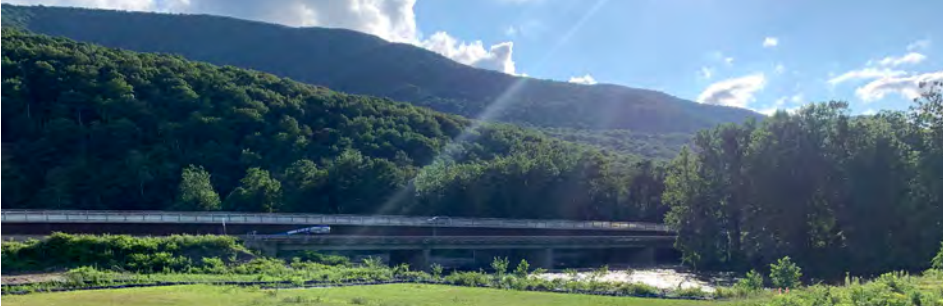
Photo by A. Bennett

Replacement of the NY State Route 28 bridge over the Esopus Creek in Mt. Tremper with a taller and longer bridge is nearing completion. The new bridge is now open to traffic and the old bridge demolished. Replacement of the bridge was an expensive but high priority flood mitigation action recommended in the 2016 Local Flood Analysis for Phoenicia and Mt. Tremper. The flood study was carried out by the Town of Shandaken with assistance from AWSMP through the Local Flood Analysis program.

The NYSDOT continued to coordinate with Shandaken, MMI, Ulster County, and the NYS Department of Environmental Conservation to complete bridge design in 2019 and construction in 2021. The new bridge is longer at 800 ft with five spans than the old bridge at 366 ft with four spans, and reduces the number of piers in the creek from two to one pier.

In addition to substantially enlarging the bridge, the project elevates and reconfigures the intersection of Route 212 with Route 28 and removes a NYSDEC flood control berm to allow stream flows back onto the floodplain. The combined actions will lower flood elevations in the hamlet of Mt. Tremper.

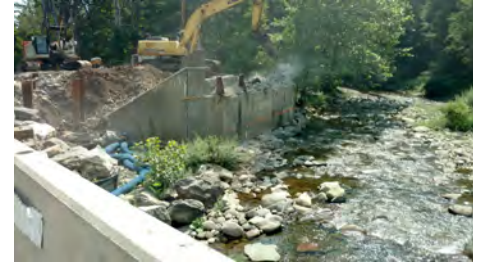
In other bridge replacement news, the Ulster County Department of Public Works (DPW) is replacing a bridge on County Route 42 or Watson Hollow Road over Maltby Hollow Creek in the Town of Olive. This bridge was identified as a flood mitigation priority in the Town of Olive's 2017 Local Flood Analysis for Boiceville and West Shokan. Local Flood Analysis is a funding and technical assistance program developed in the NYC Drinking Water Supply Watershed by county governments, non-profit partners, and the NYC Department of Environmental Protection in response to a spate of destructive and frequent flooding that occurred between 2005-2011.

One of the flood mitigation actions identified for the West Shokan hamlet was enlargement of the Maltby Hollow bridge to prevent flooding and erosion that is caused by blocked flows. The bridge was constructed in 1957 with a 61-ft span that can pass the 100-year storm event if not blocked by large wood and debris. Blockage reduces the capacity of the bridge, causing it to overtop with water. Construction of the new 100-ft span bridge was modeled to pass the 500-year storm flow or the 100-year flow with a 50% blockage. A larger bridge was warranted due to the amount of road traffic and an 80-minute detour caused by bridge closure due to flooding.

A temporary bridge will allow traffic to cross Maltby Hollow Creek during construction that is scheduled for completion in 2021.

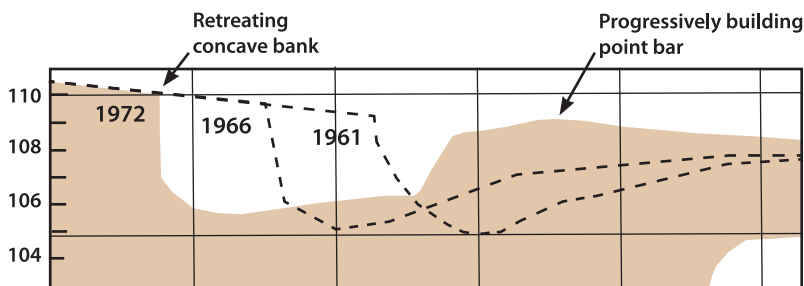
*Progression of an eroding stream bank that is eroding on the left while the point bar is building on the right. Notice the similar cross-sectional area over time. Illustration adapted from "A View of the River" by Luna Leopold (1994, 6th ed., pg. 8).*

In naturally stable streams with healthy riparian vegetation, lateral bank retreat (i.e., property loss) from erosion is gradual, often measured in inches per year, even in years with significant flood events. In addition, natural erosion is typically balanced by a similar amount of deposition. So, while the bank may be eroding on the outside of a meander bend, a point bar on the inside of the bend is building at the same rate. In this way the stream channel maintains its cross-sectional area and rough shape while slowly migrating across the valley floor over time, as seen in the illustration below.

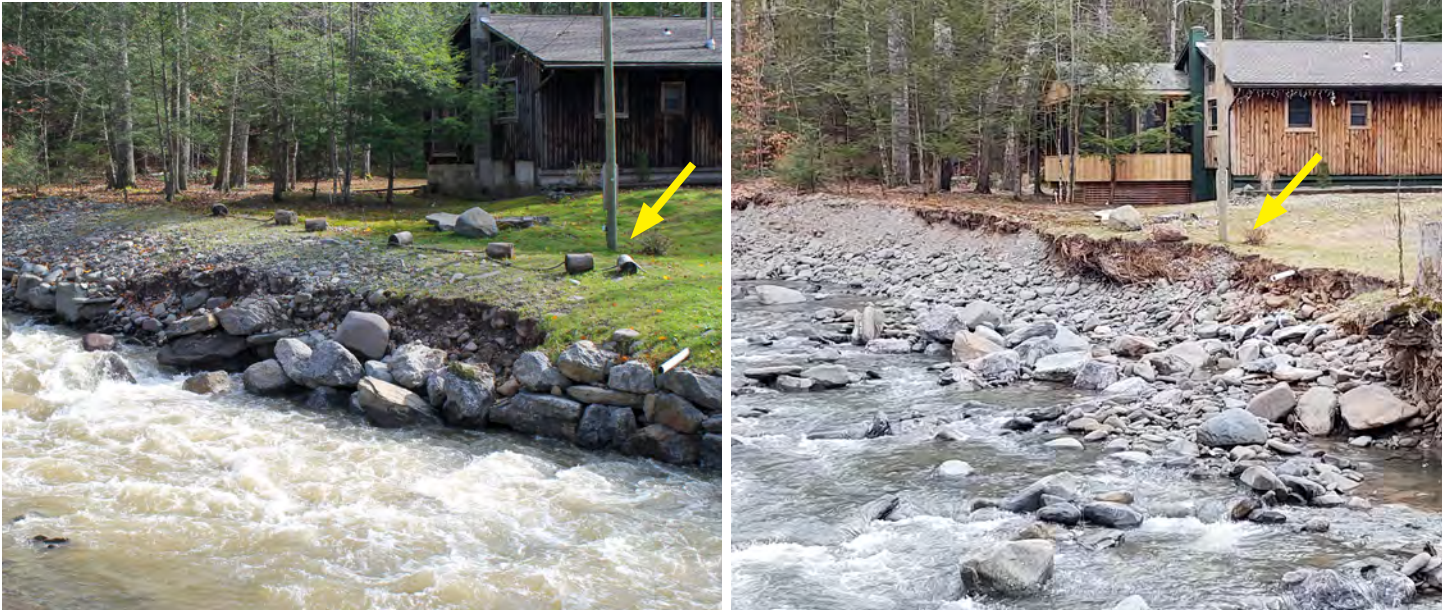
*Above: Photos on an unstable eroding stream bank from before (left) and after (right) a moderate flood event.*

Anthropogenic erosion is often rapid and dramatic, especially during and after flood events, when a stream bank can retreat tens of feet in a matter of hours. This type of bank erosion is not balanced by point bar deposition nor do the channel dimensions remain the same.
