ASHOKAN WATERSHED STREAM MANAGEMENT PROGRAM

AWSMP_1008T2

Project Report:

Below Fawn Hill, Woodland Valley Road Bank Stabilization Project, Town of Shandaken, Ulster County, New York

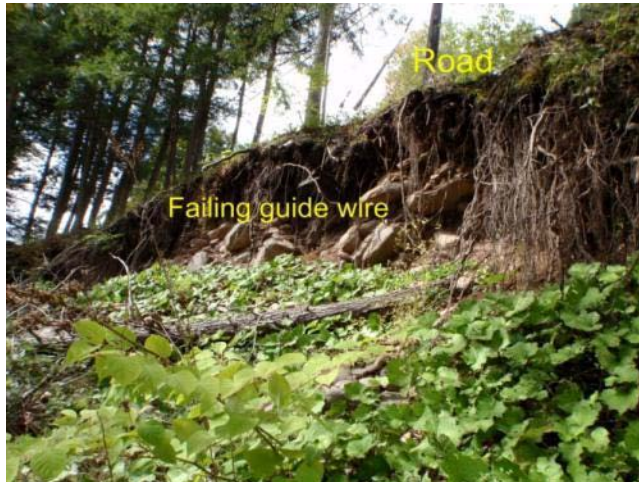
Figure 1 Eroding stream bank and area of undercut road.

The project site had previously been identified as a potential problem by the property owner and by the Town of Shandaken Highway Superintendent, Eric Hofmeister. Hofmeister approached the Ashokan Watershed Stream Management Program (AWSMP) office in September 2009 for possible funding and technical assistance. The eroding stream bank was approximately 25ft high and 100ft long. The bank was composed from the bottom up of dense clay-rich glacial till, old stream deposits, and road fill material. The Woodland Valley Road runs adjacent to the bank and portions of the road are approximately 5ft from the edge of the eroding bank. The stream channel at the base of the eroding area is primarily a bedrock controlled pool. Bedrock forms the entire right descending bank and channel bed, therefore erosional migration of the channel was expected to continue toward the road.

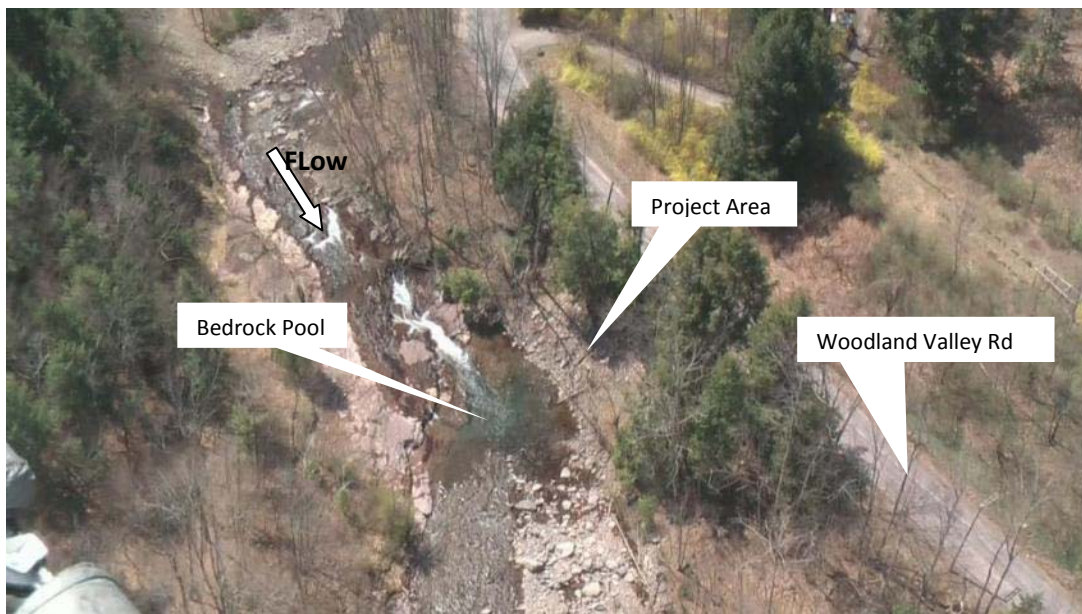
Figure 2 Aerial photo of Woodland Valley Creek (2008), bedrock controlled pool, project location and proximity to the Woodland Valley Road.

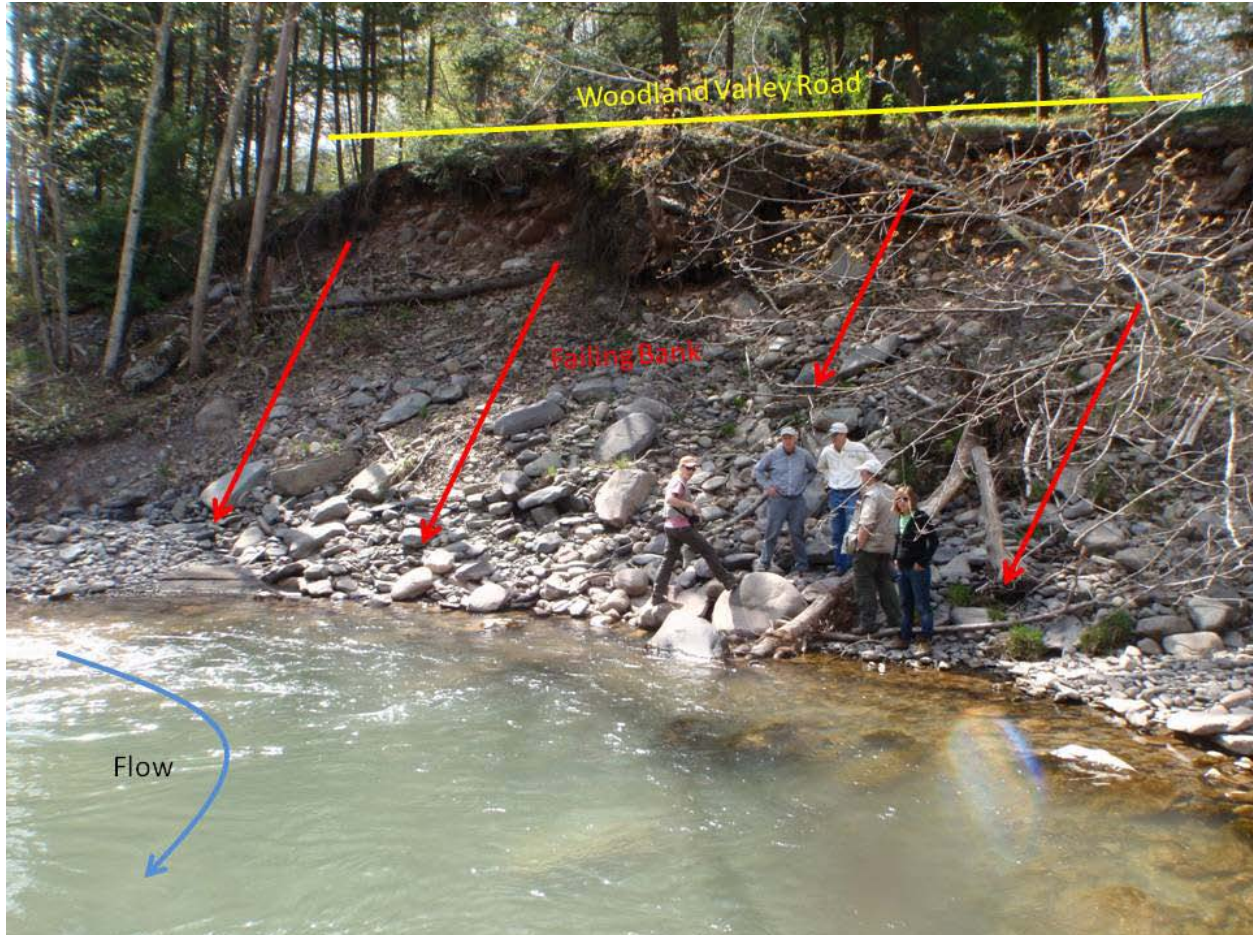
A thorough investigation of this site was completed by staff from UC SWCD and from the NRCS. A survey, hillslope evaluation and stream function were part of our investigation into this failure.

Figure 3 Visual analysis depicting pool, failing bank and location of Woodland Valley Road.

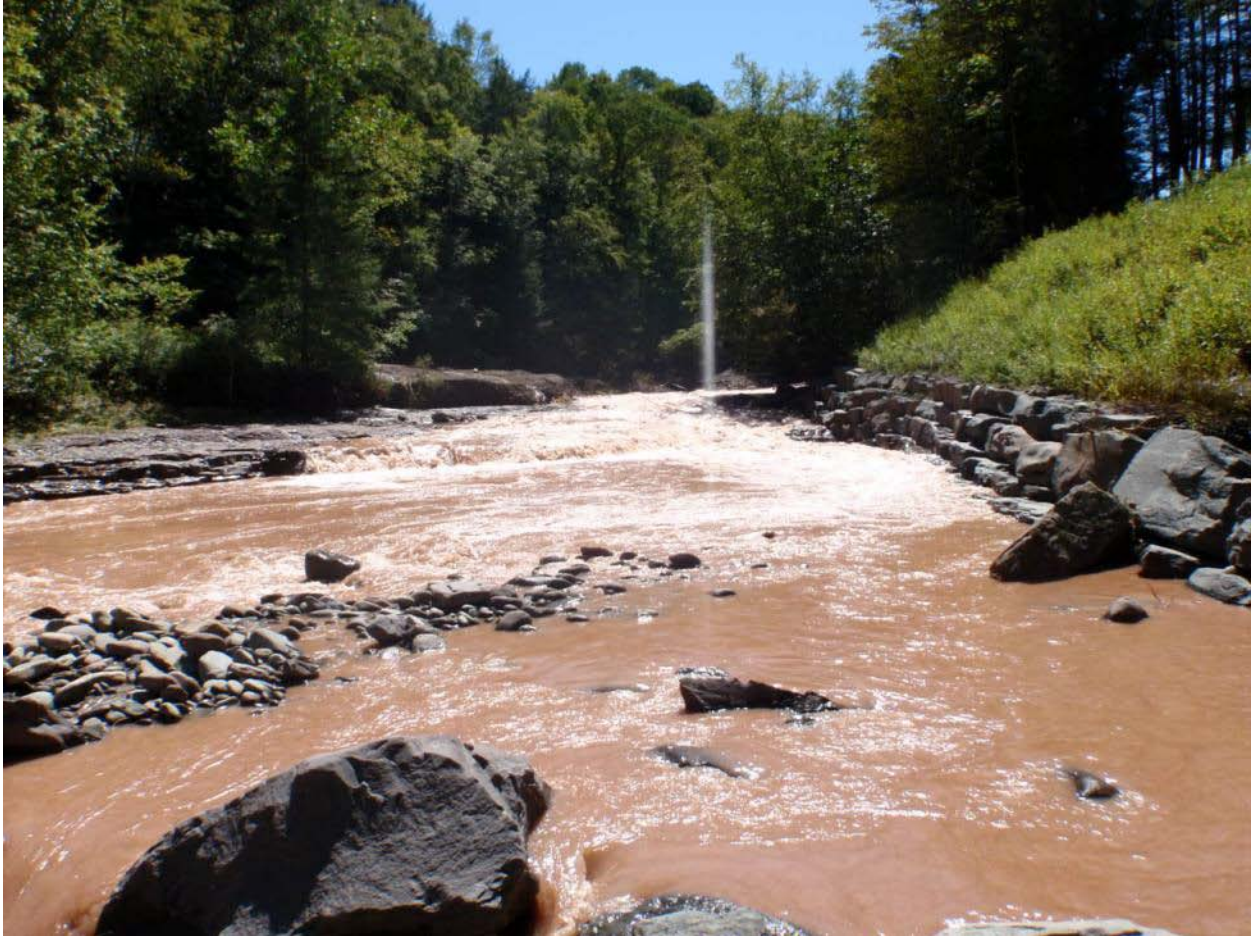
Construction of the stacked rock wall was completed September 29th 2010, and the upper portion bio-engineered soil slope was completed December 10th 2010. Since completed, the rock wall has withstood three (3) major flood events, including Hurricane Irene with little to no damage.

Figure 6 Post-Hurricane Irene (9/4/2011). Observations indicate rock wall and bio-engineered slope no damage.

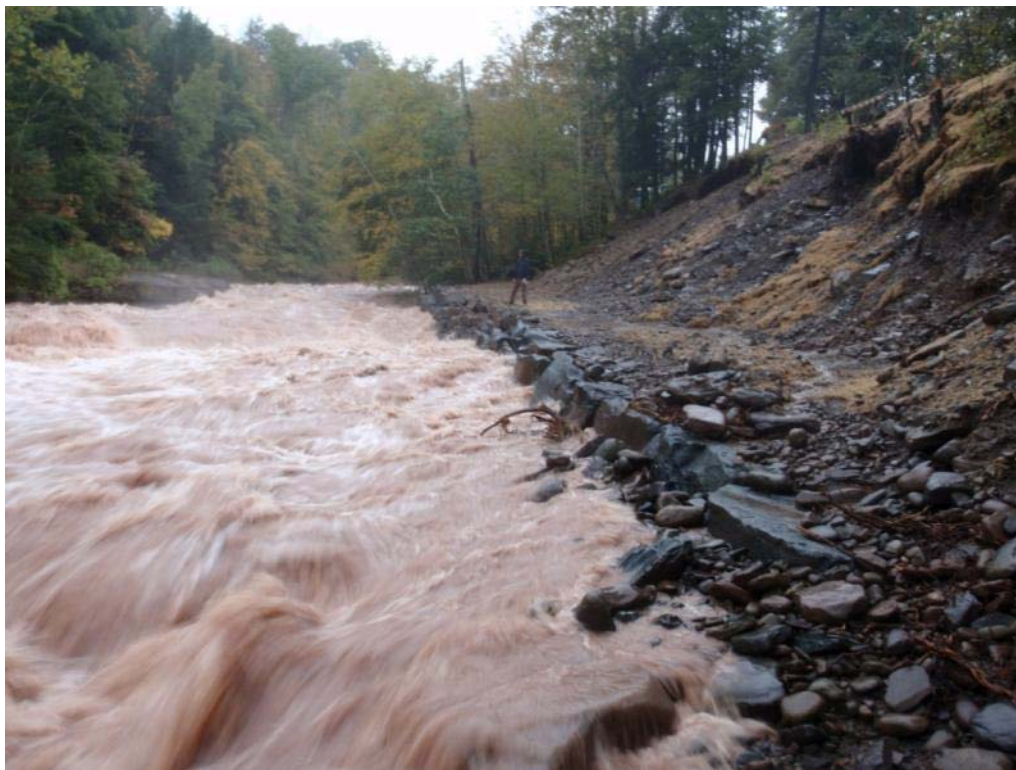
Figure 11 October 1st 2010 flood event approximately one hour after peak stage

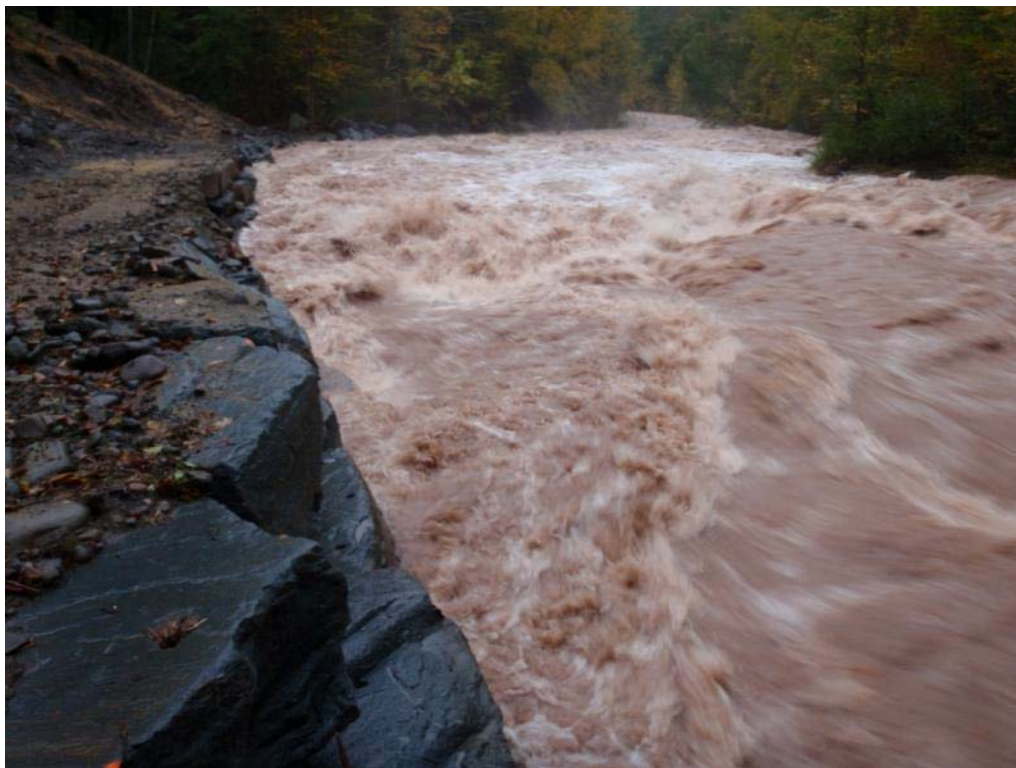
Figure 12 View looking downstream during October 1st 2010 flood event
