Flood Hazard Mitigation Alternatives: Phoenicia, NY

Shandaken Town Board
September 8, 2025

Objective: re-evaluate LFA recommendations and develop additional potential flood hazard mitigation strategies for Phoenicia

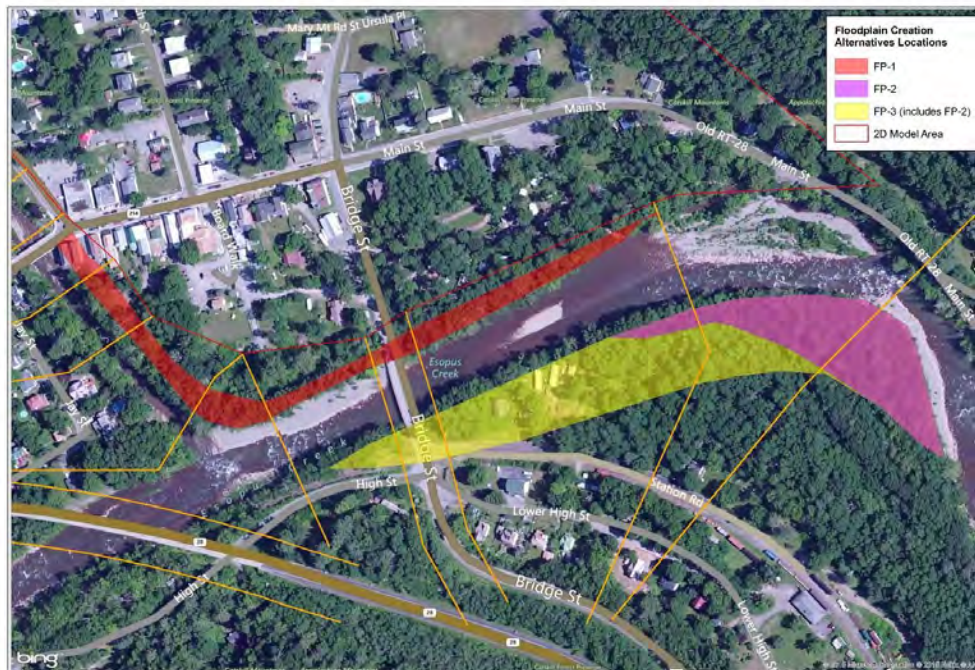
Rendering of conceptual
Esopus Creek floodplain
benches and replacement
Bridge Street bridge from
2016 Local Flood Analysis

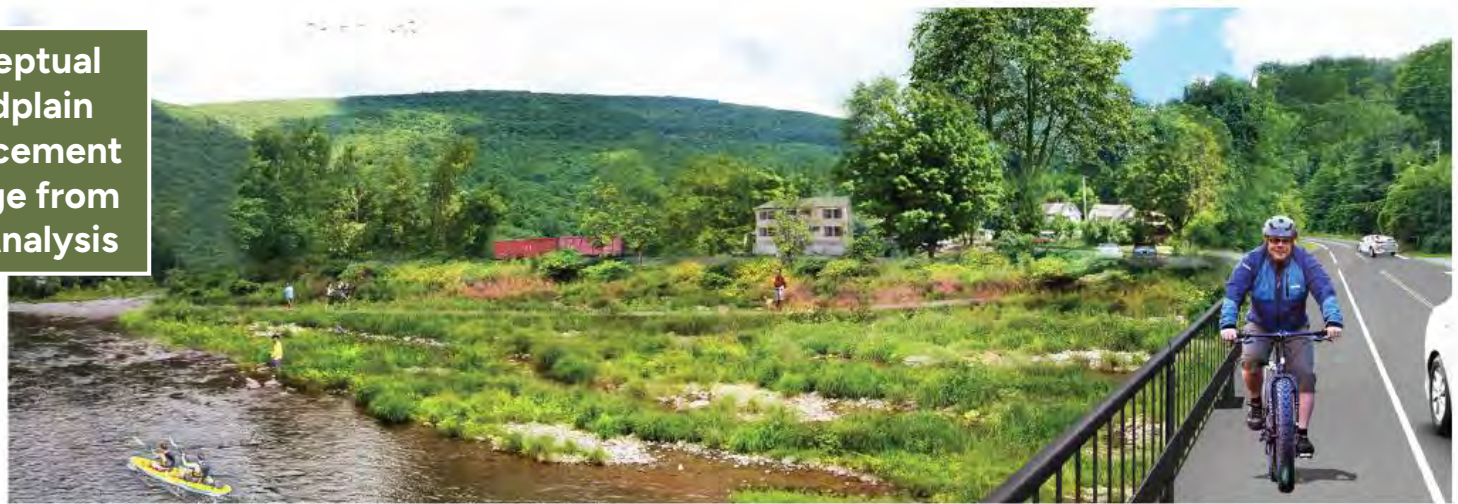
ENHANCED FLOODPLAIN AND NEW BRIDGE STREET BRIDGE DURING NORMAL FLOW CONDITIONS

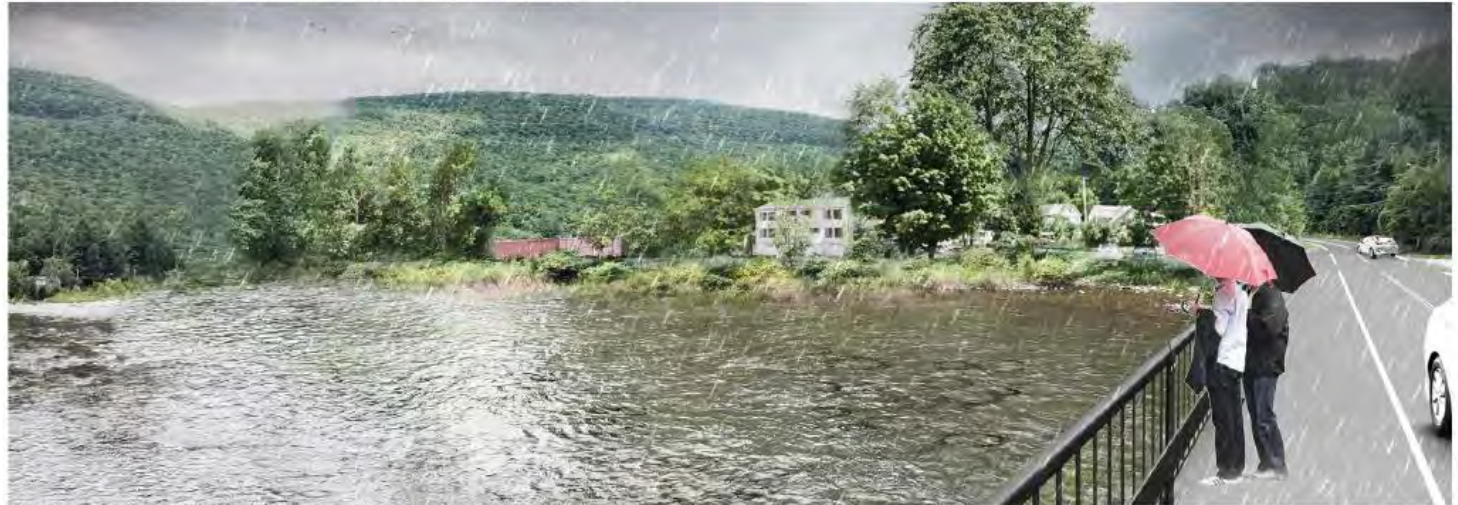
ENHANCED FLOODPLAIN AND NEW BRIDGE STREET BRIDGE DURING FLOOD CONDITIONS

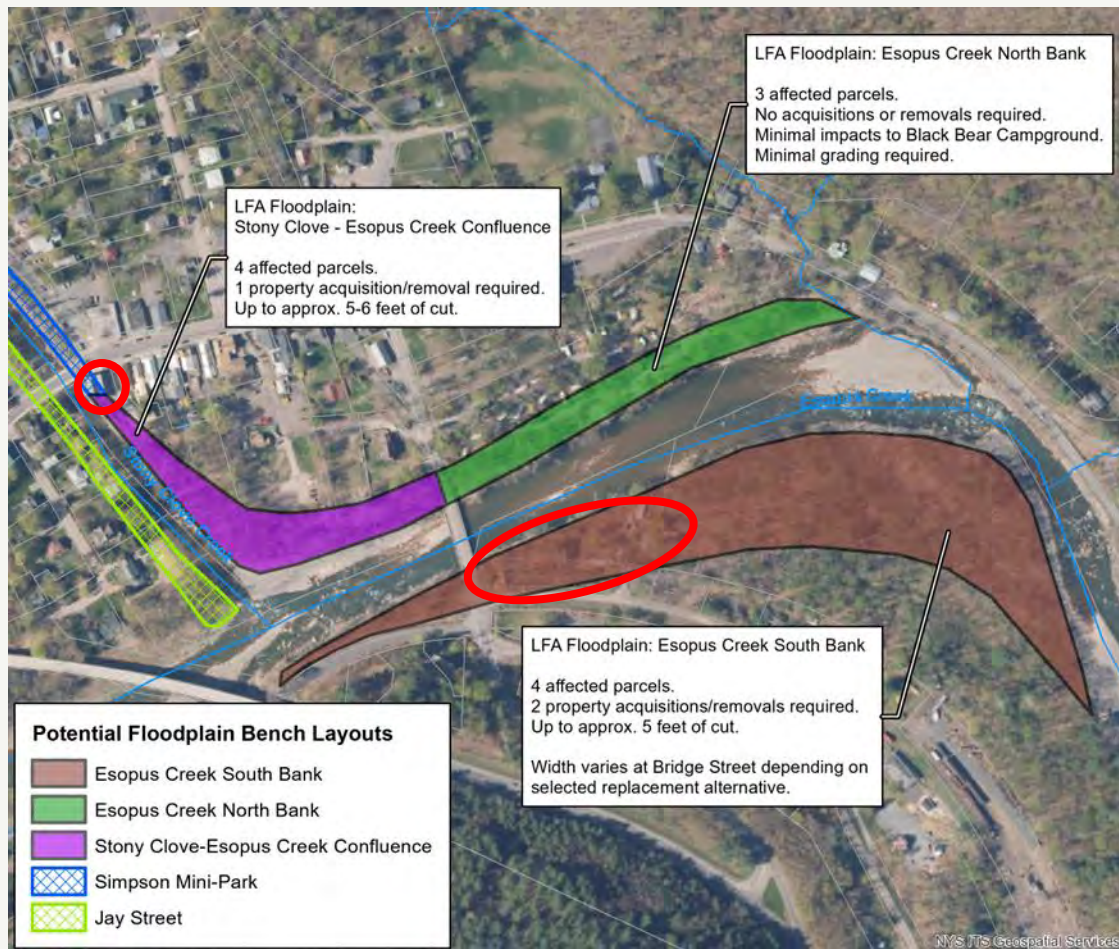
Possible Floodplain Enhancements: Esopus Creek

- Can improve hydraulic performance of Bridge Street bridge replacement
- Can alleviate much of the flooding in downtown Phoenicia caused by Esopus Creek
- Disturbance to private properties; acquisitions & removals

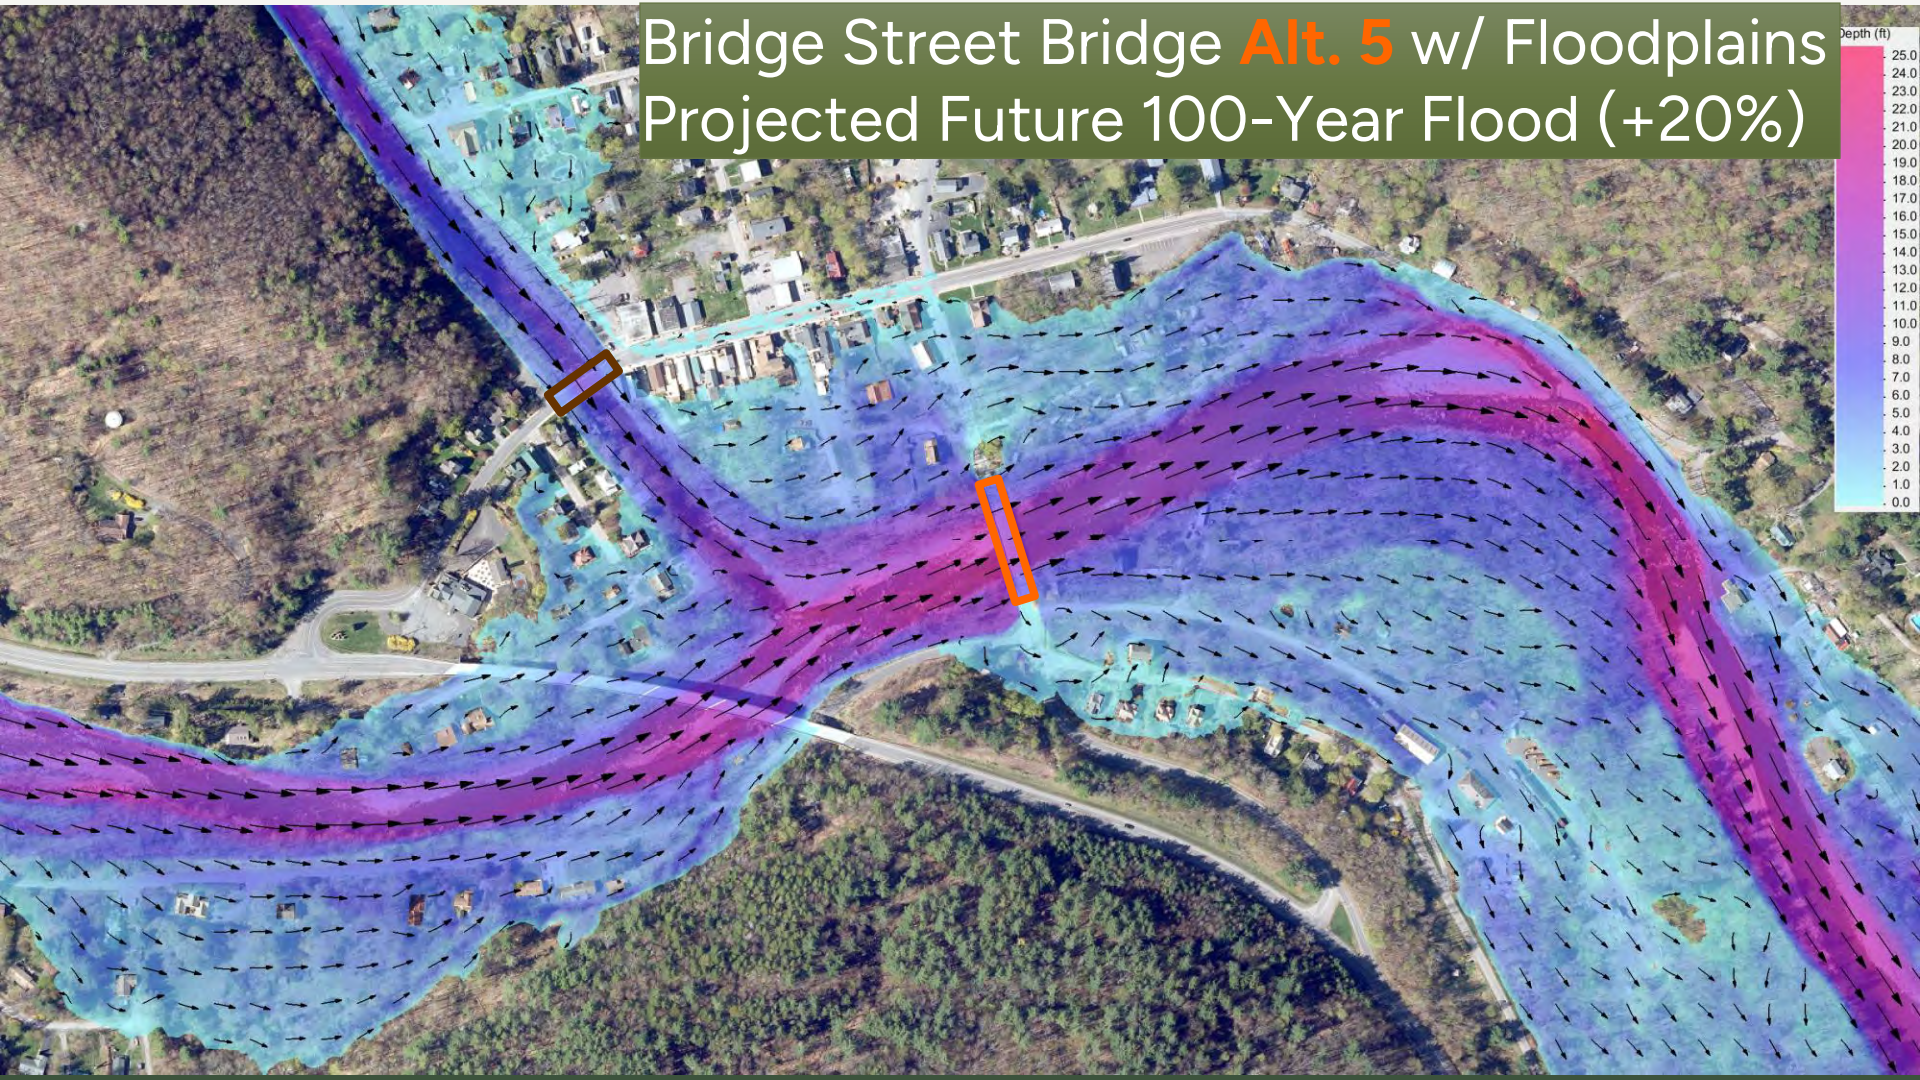
Bridge Street Bridge **Alt. 5** w/ Floodplains Projected Future 100-Year Flood (+20%)

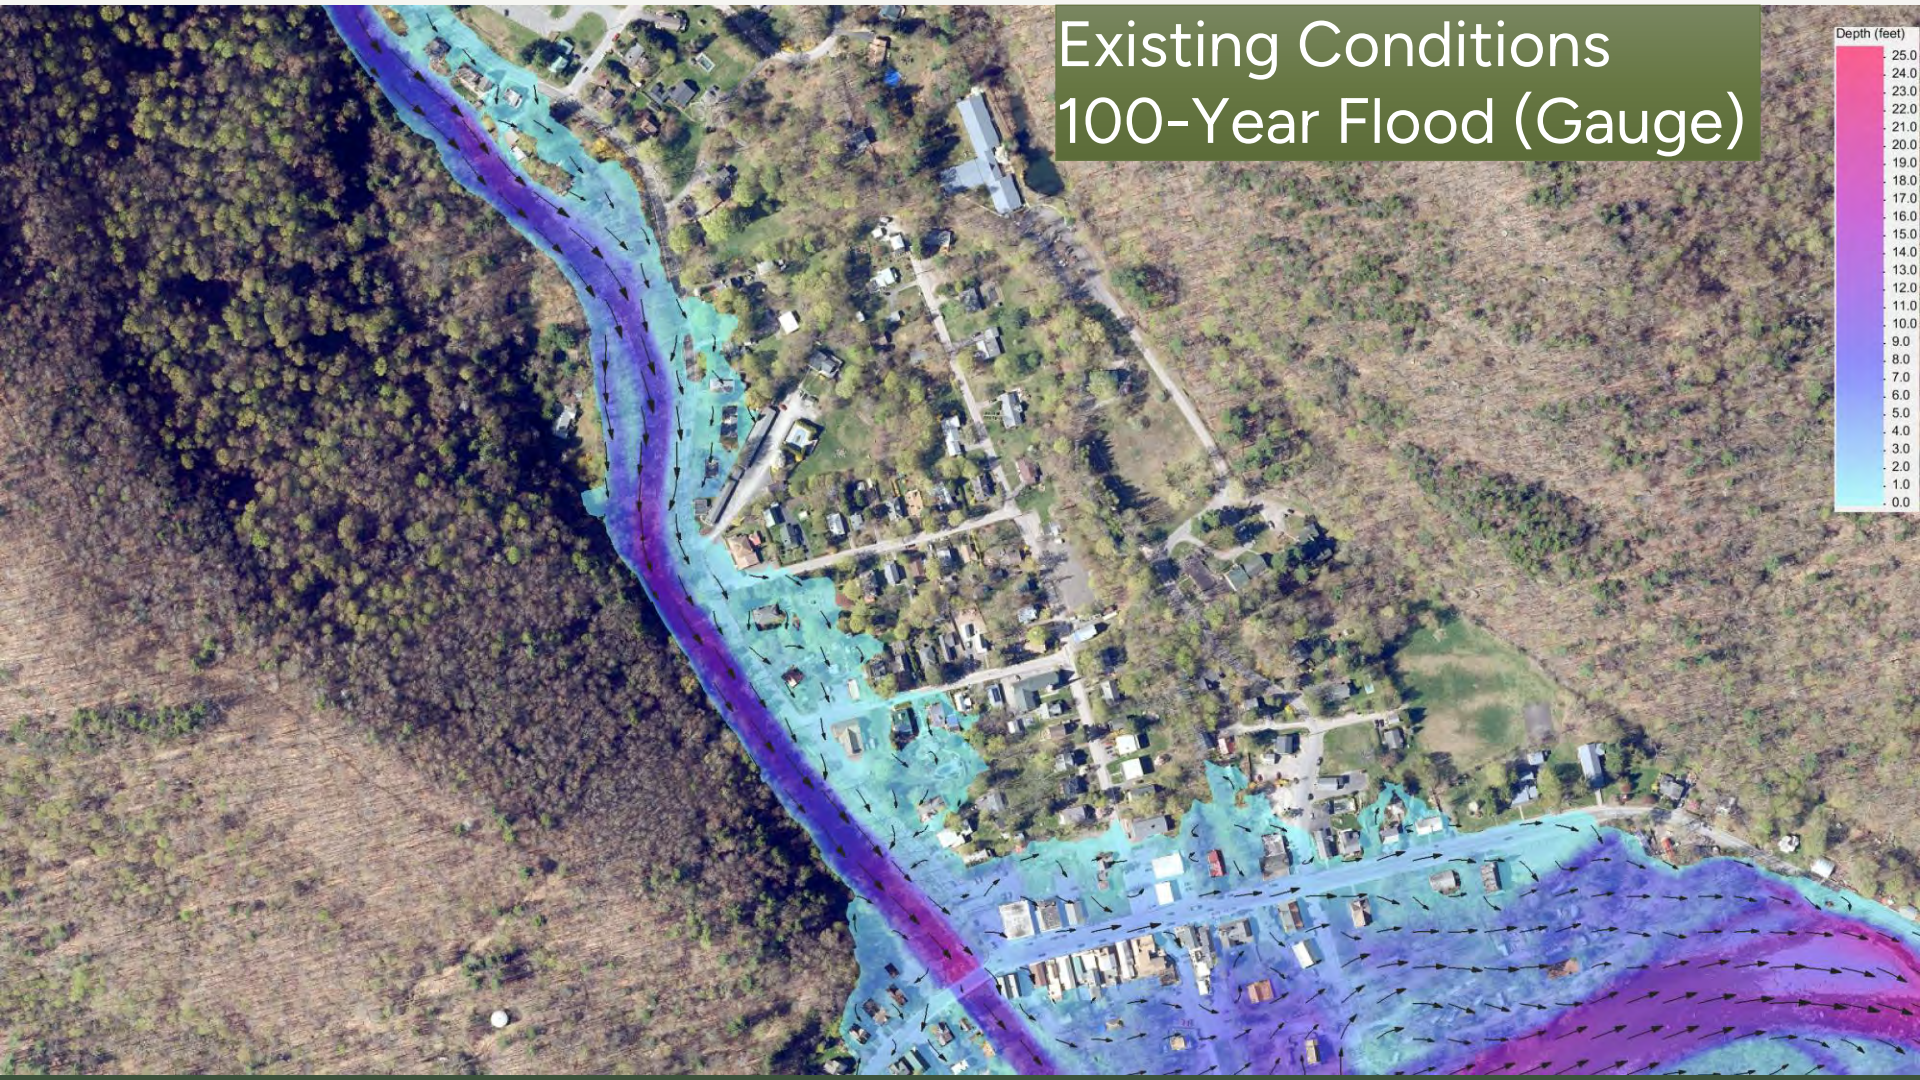
Existing Conditions 100-Year Flood (Gauge)

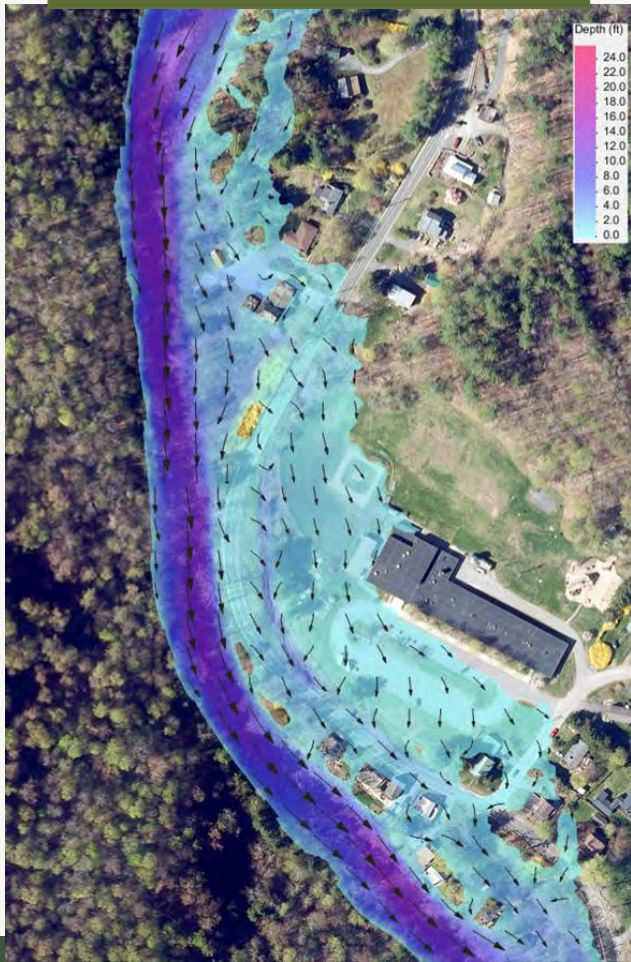
Existing 100-Year
Flood (FEMA)

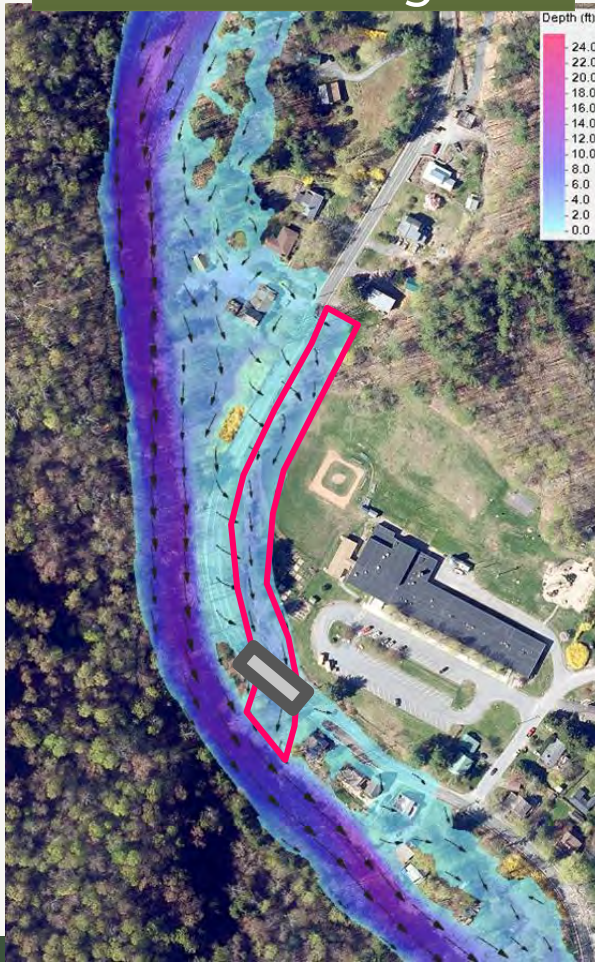
Swale Enhancement
& NY-214 Bridge

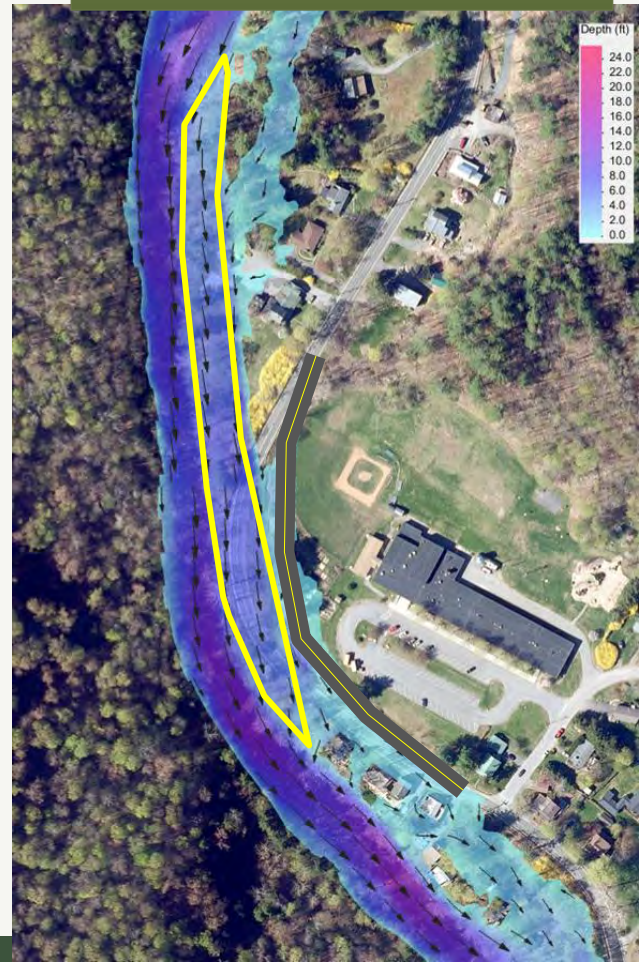
Floodplain Bench &
NY-214 Relocation
