# Hamlet of Chichester Local Flood Analysis

Public Meeting #2

September 25, 2026

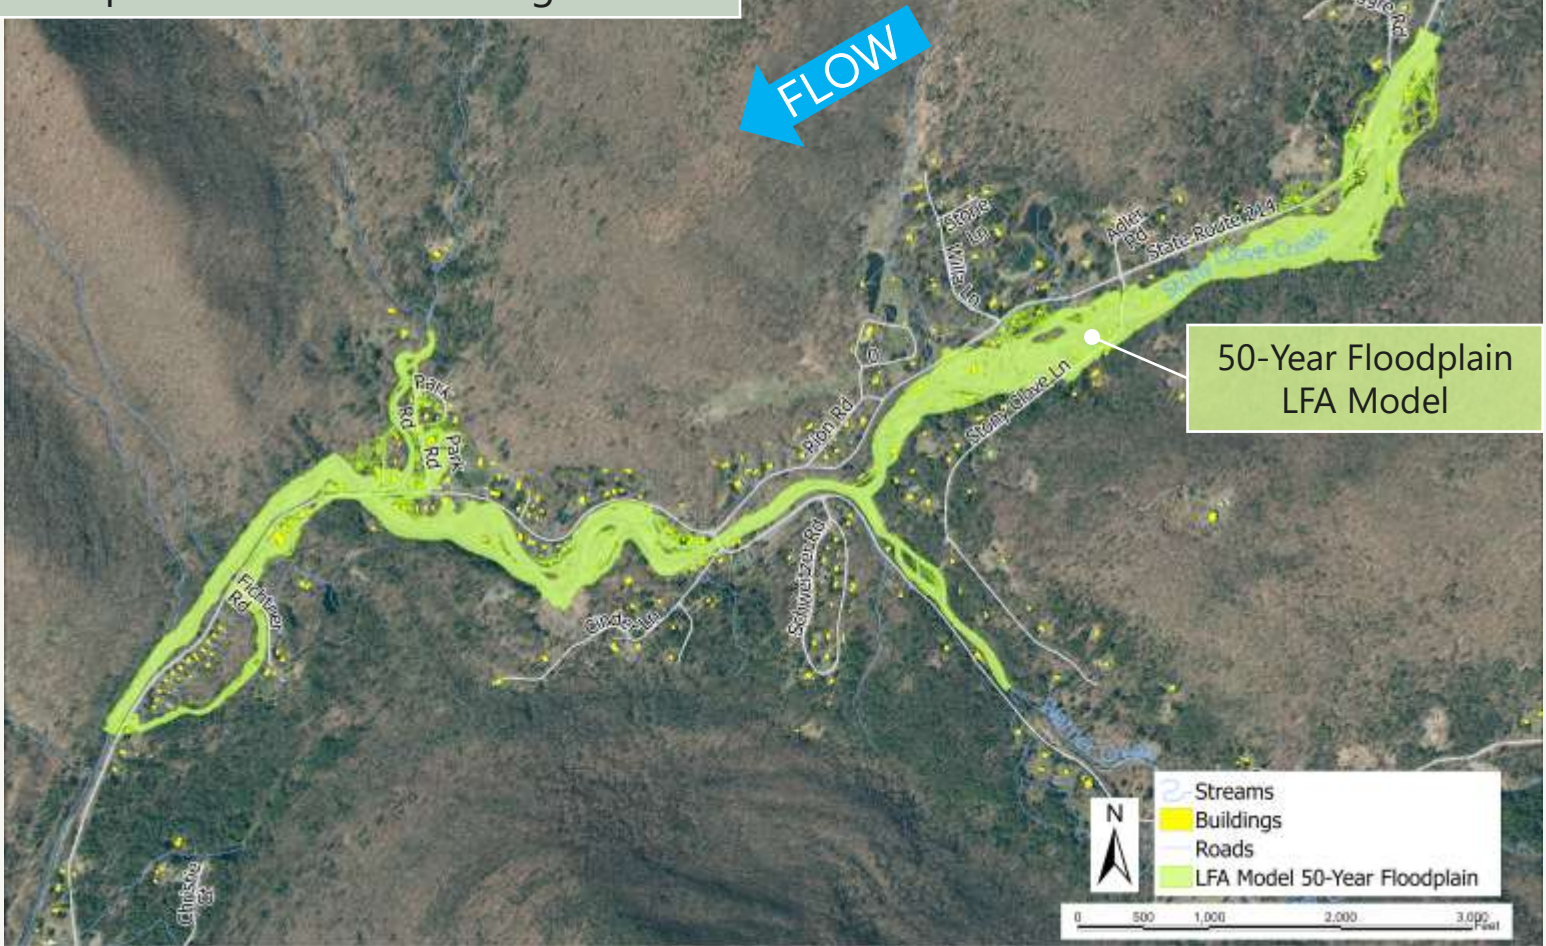
50-Year flood:  
Comparable to Tropical Storm Irene in August 2011

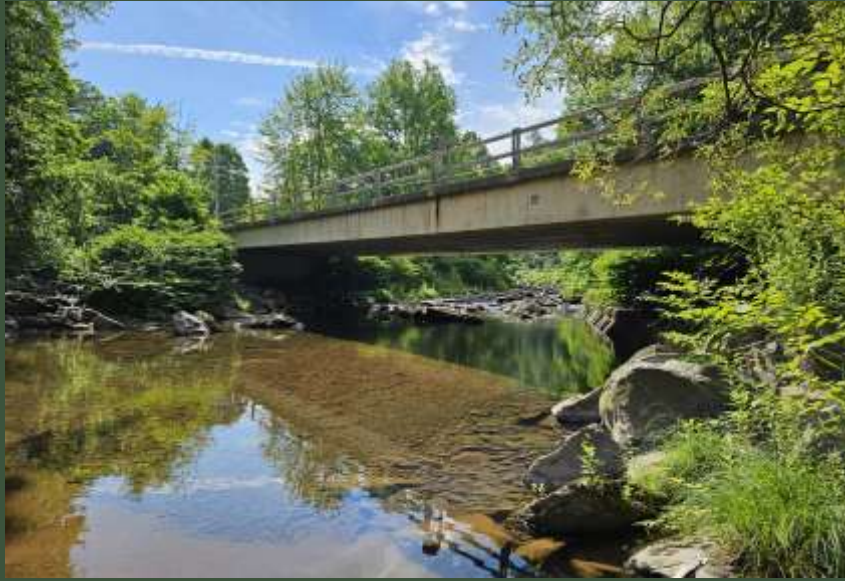
# NY-214 Bridge

- Backwaters from undersized bridge contribute to flooding of several properties.
- Flanking flows cause significant flooding of NY-214, Fichtner Road, and adjacent properties.

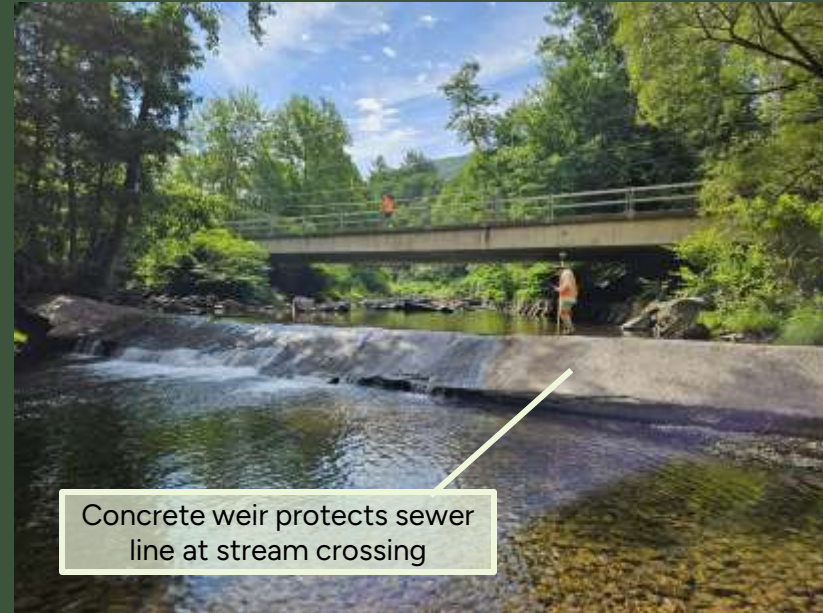
Sewer line weir contributes negatively to bridge hydraulic performance – recommend removing weir and replacing sewer with alternative stream crossing:

Concrete weir protects sewer line at stream crossing

- Relocate deeper beneath streambed (if practical – possible slope limitations)
- Install pump station and affix sewer line to downstream fascia of bridge

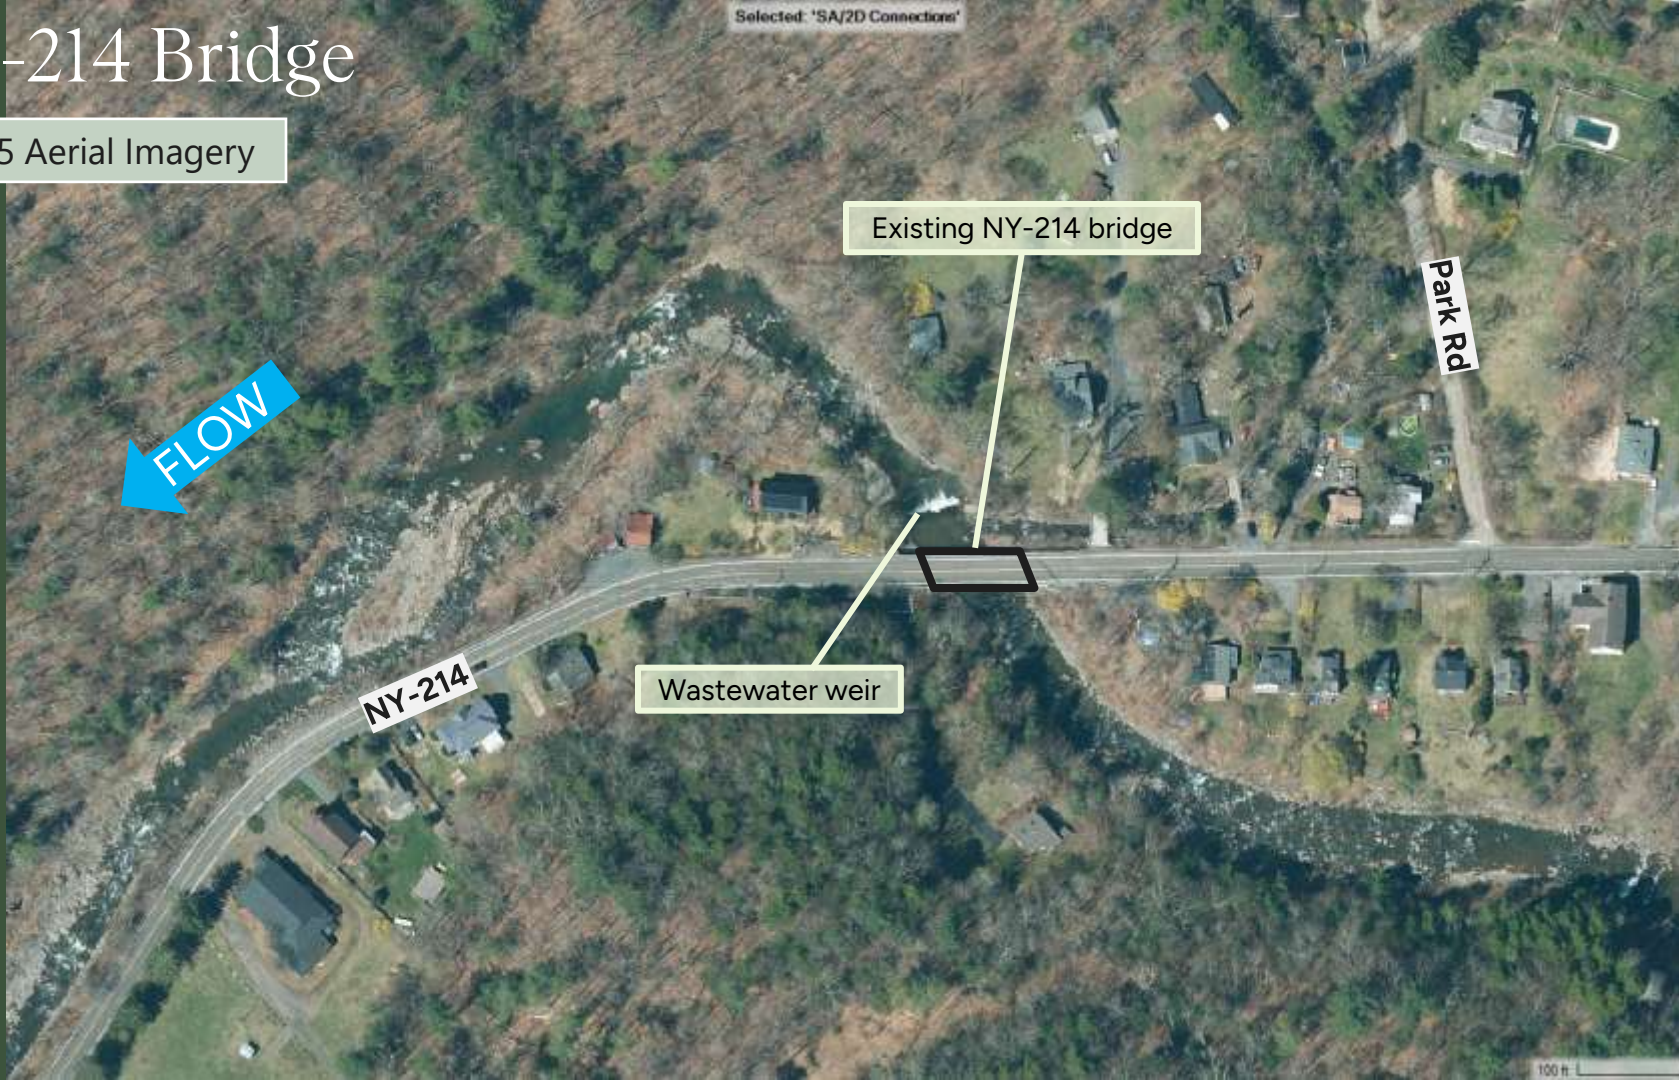
# NY-214 Bridge

2025 Aerial Imagery

Existing NY-214 bridge

Wastewater weir

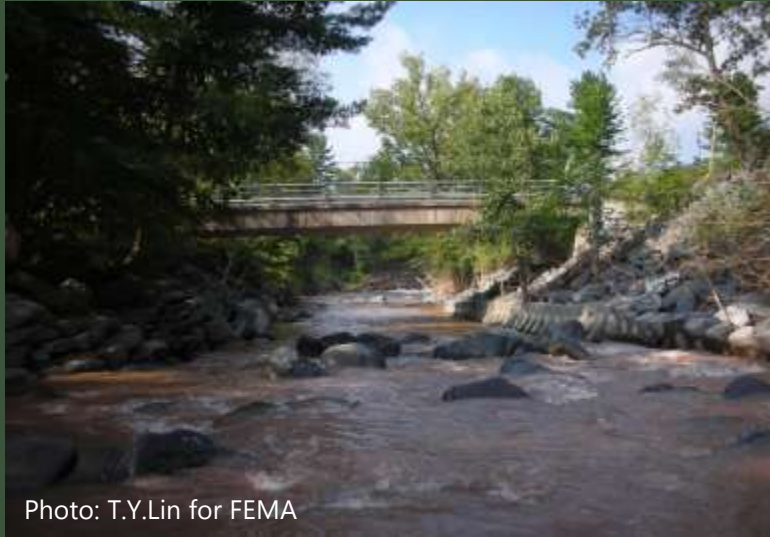
# Silver Hollow Road Bridge

- Crossing located in steep, confined, high-energy reach of Stony Clove Creek.
- Extreme velocities and shear stress conditions.

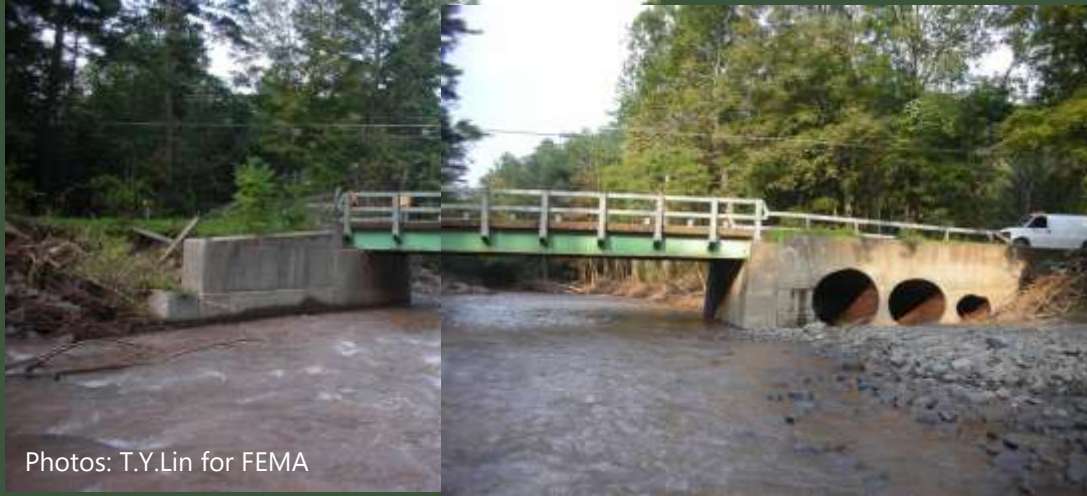
# Stony Clove Lane Bridge

- Undersized crossing has been damaged in the past.
- Relief culverts provide marginal additional conveyance and require frequent maintenance.
- Stream bed and bank stabilization completed in 2014.
- Bridge replacement previously recommended in Ulster County Hazard Mitigation Plan.
- Upstream flood-damaged home removed in 2017.

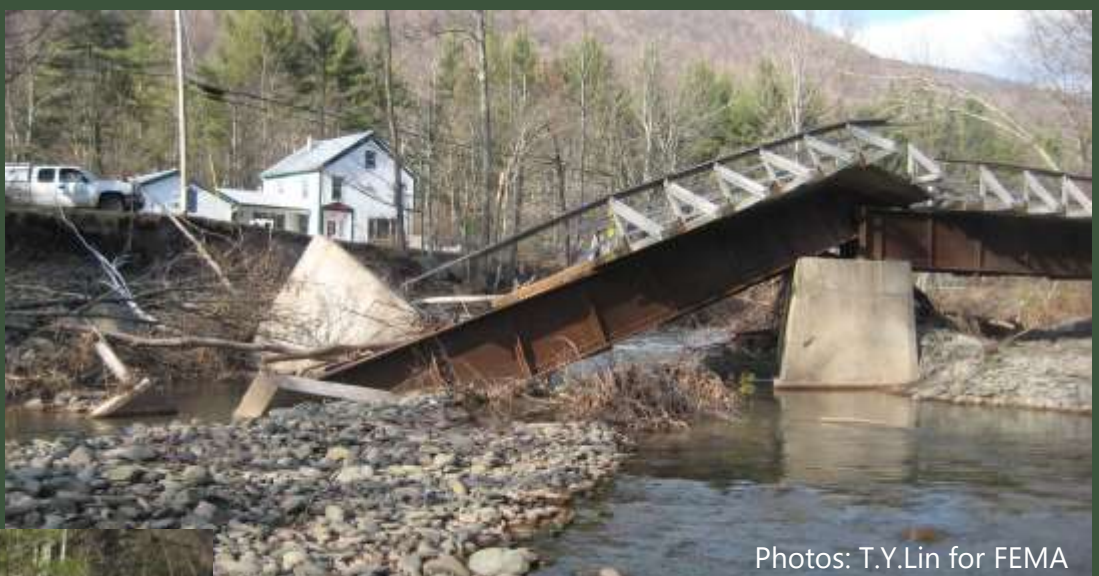
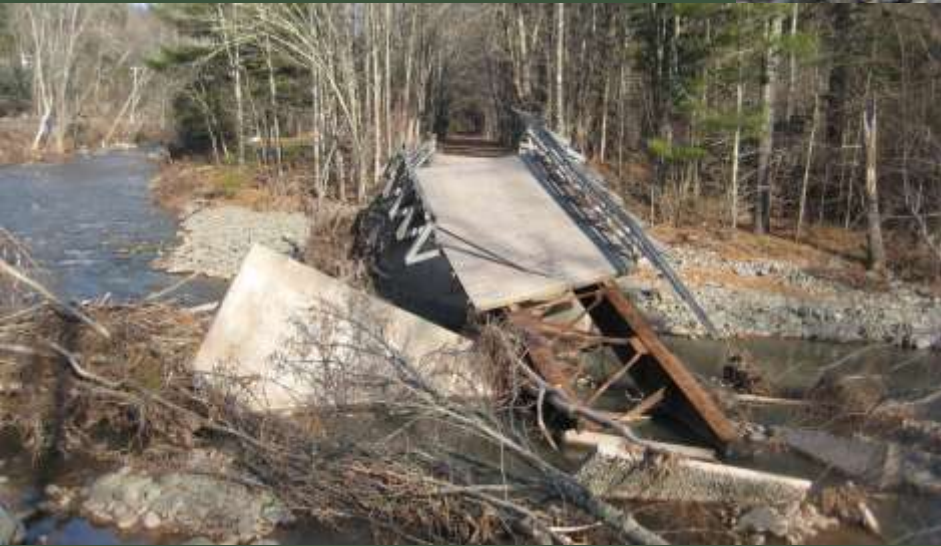
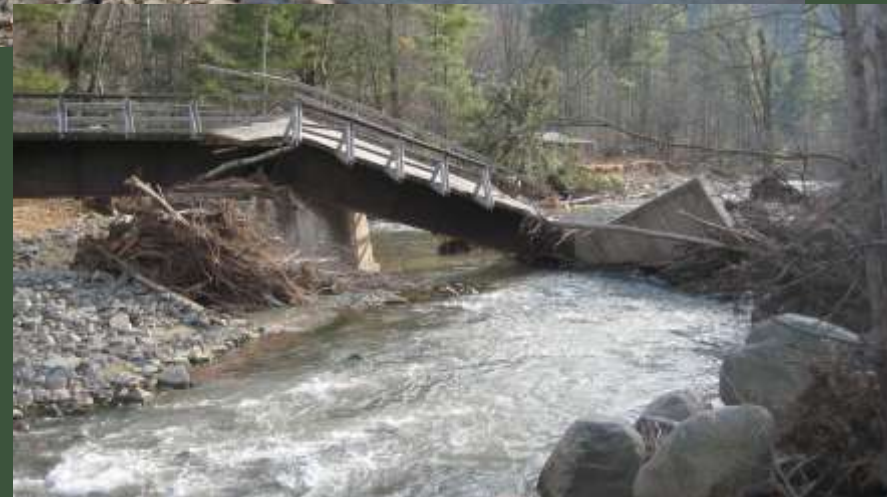
# Grubman Road Bridge

Grubman Road bridge  
damaged in Tropical  
Storm Irene (2011)

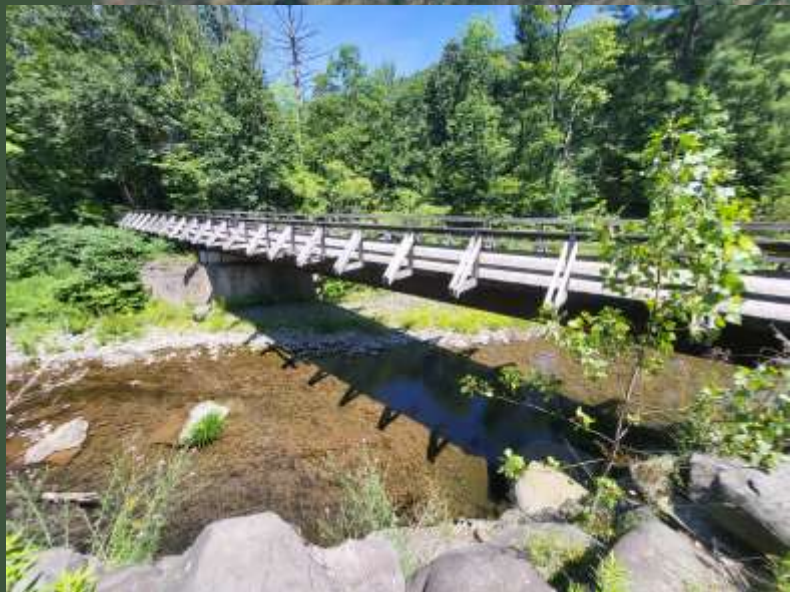
# Grubman Road Bridge (Private)

Existing Grubman  
Road bridge

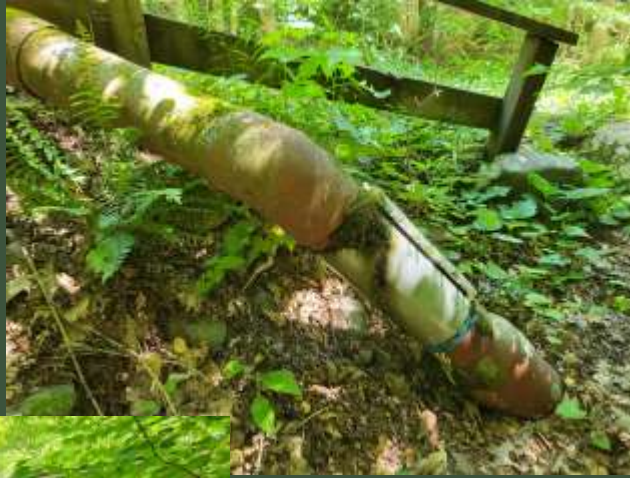
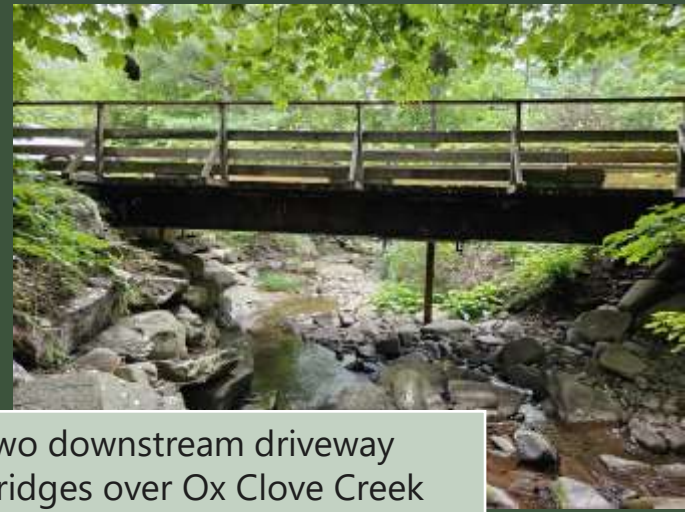
# Private Bridges – Ox Clove Creek

Water supply line on private driveway bridge over Ox Clove Creek is vulnerable to damage during floods

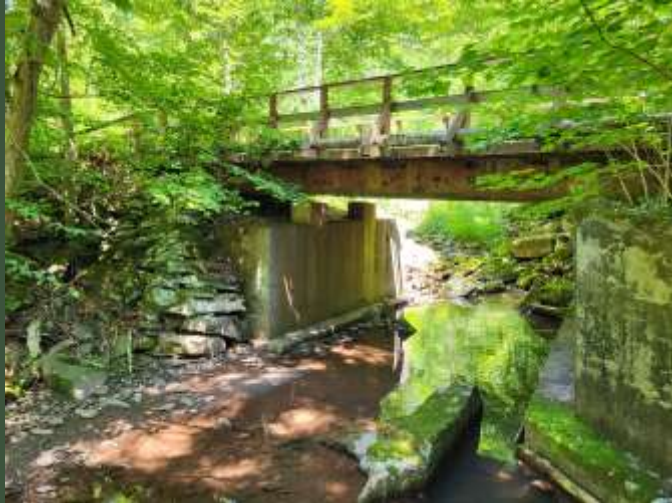
Two downstream driveway bridges over Ox Clove Creek can contribute to flooding of NY-214 and nearby properties

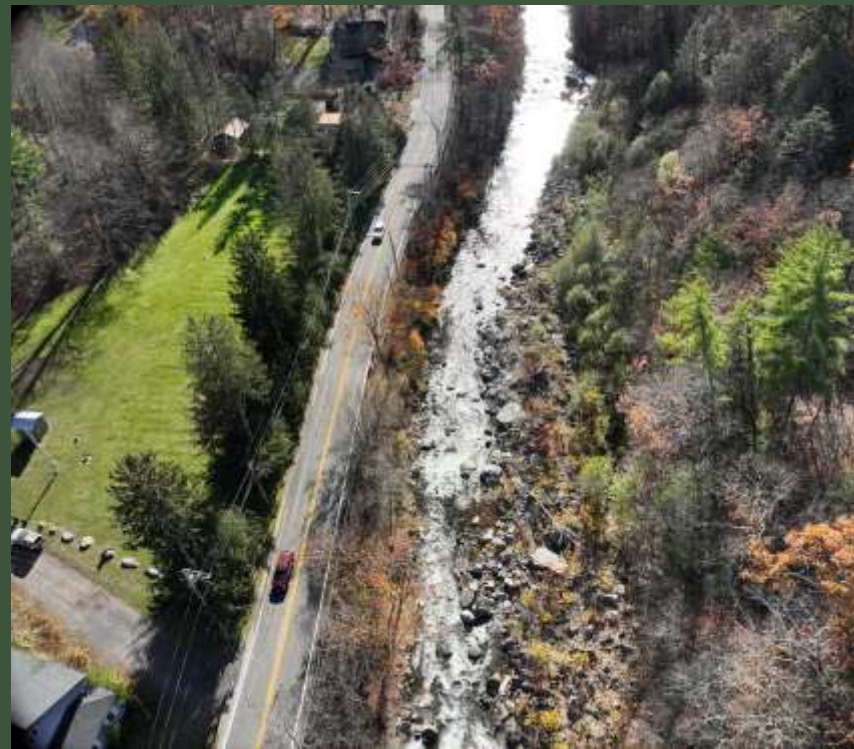
July 29, 2026 flood  
modeling: 18+ fps
